**Urgent: Field Safety Notice**  
**Update to October 2016 Field Action:**  
**Important information regarding the Medtronic Model 37751 Recharger**  
(Included in Kit Models 37754, 97754, and 37651)

February 2019

Medtronic reference: FA735 Phase II

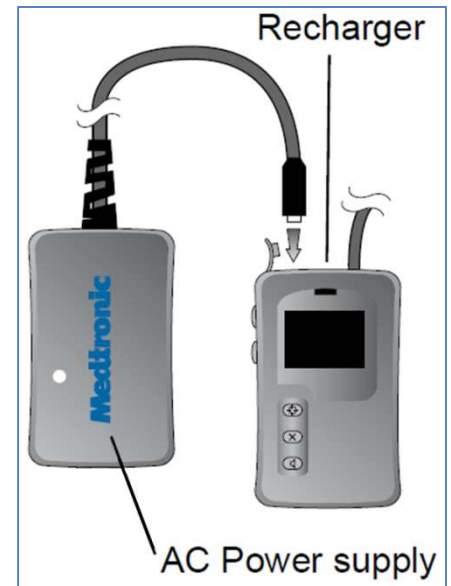
- For product manufactured prior to the design change (Serial numbers starting with "4" [e.g. "NKA4" or "NKU4"]):
  - To prevent this unresponsive error state, the Recharger should be plugged into the AC power supply (by aligning white triangles) prior to starting a recharging session of the neurostimulator and remain connected to the AC power supply until the recharging session has finished (see Figure 1). Note: The AC power supply does not need to be plugged into a power outlet if the Recharger is charged.

- If the Recharger is not connected to the AC power supply during a recharging session of the neurostimulator, the unresponsive error state may occur. Note: This issue can recur after reset if the recharging instructions are not completely followed.

- For product manufactured after the design change (Serial numbers starting with "5" [e.g. "NKA5" or "NKU5"]):
  - Follow the instructions included with the Charging System user manual shipped with the device. Instructions in the user manual do not require the Recharger to be plugged into the AC power supply for a recharging session to occur.
