Subject: Pacemakers – Technical programming information on Minute Ventilation Sensor.
 Ref.: 92186345-FA

Product name	Models
VALITUDE™ CRT-P	U125, U128
ACCOLADE™ Pacemakers	L300, L301, L310, L311, L321, L331
ESSENTIO™ Pacemakers	L100, L101, L110, L111, L121, L131
VISIONIST™ CRT-P	U225, U226, U228
PROPONENT™ Pacemakers	L200, L201, L209, L210, L211, L221, L231
ALTRUA™ 2 Pacemakers	S701, S702, S722

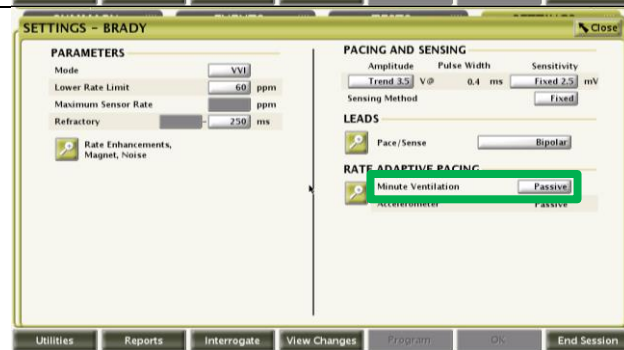
3. On Settings – Brady page, in the Rate Adaptive Pacing section, review the Minute Ventilation programmed value.

If the value is "Passive" or "ON" the MV sensor is enabled.

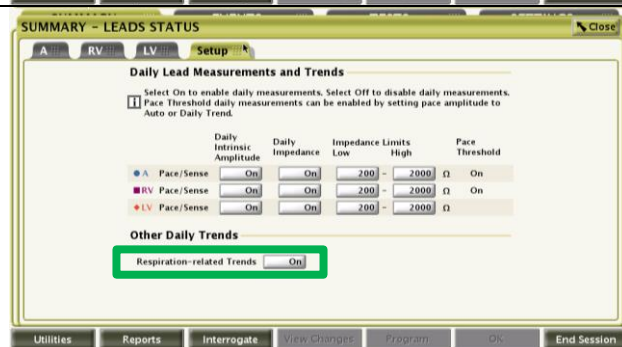
3. On the Summary – Leads Status page, in the Other Daily Trends section, review the Respiration-related Trends value.

If the value is “ON” the MV sensor is enabled.
