Subject: Urgent Field Safety Notice Software Update – Minute Ventilation Sensor Software Update Available for Pacemakers (see previous communication issued in December 2017 with reference 92186345-FA).

Summary Field Safety Notice (FSN)

Boston Scientific Software Update for MV Sensor Oversensing

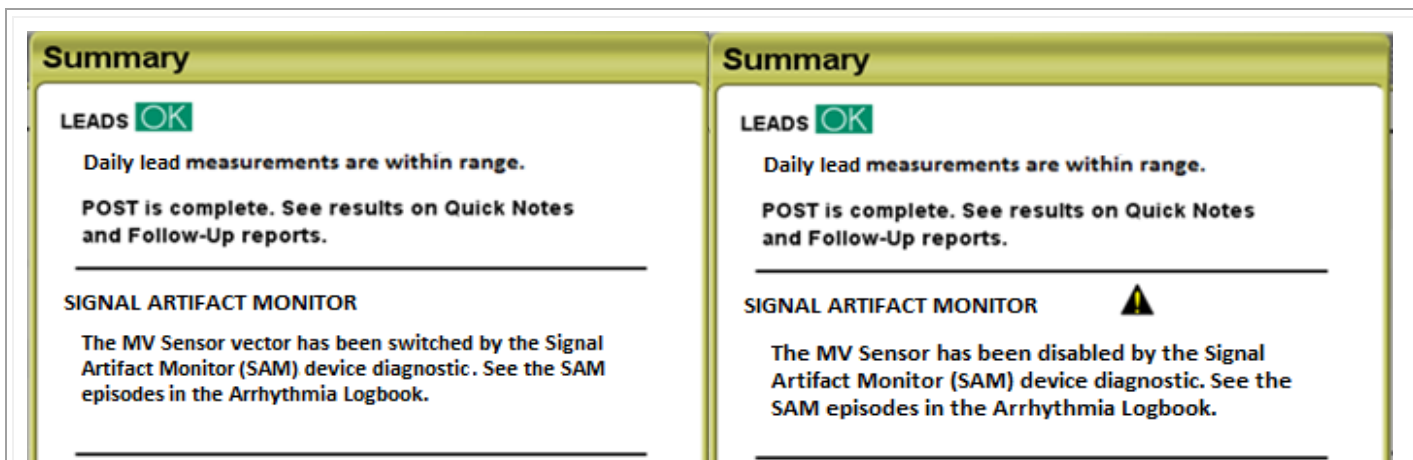
Figure 1. Summary dialogue presented at the next programmer interrogation after the MV sensor vector has been switched or MV disabled by the Signal Artifact Monitor.

4. If the MV sensor is disabled by the SAM, evaluate lead integrity and lead connection before re-programming the MV vector or programming the MV sensor to ON, Passive, or ATR Only. SAM episode data may assist in determining the source of transient impedance conditions. Contact Technical Services to explore all non-invasive programming options prior to surgical intervention if transient, abrupt changes in impedance measurements, or out-of-range impedance measurements are observed.

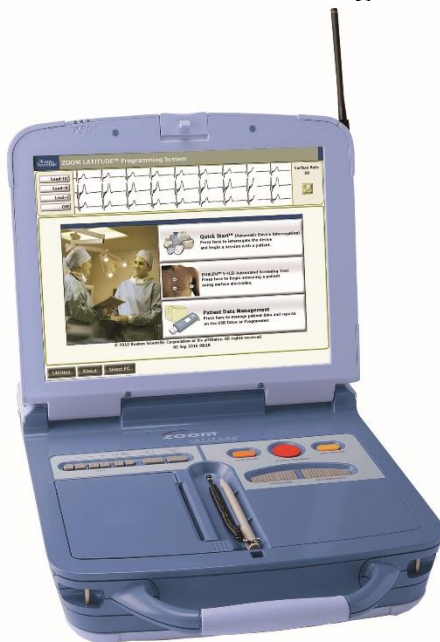
Model 3120 ZOOM™ Programmer

Select About button and Confirm Software Model and Version

Confirm Model 2869 v2.06 is installed on the About Screen

1. Confirm all your center's/clinic's Model 3120 ZOOM programmers are upgraded with Model 2869 v2.06 the software. Appendix B shows how the software model and version number can be identified.
