FSN _72800696 Revision: 01

URGENT - Field Safety Notice

Medical Device Correction

Couch Horizontal Motion Controller

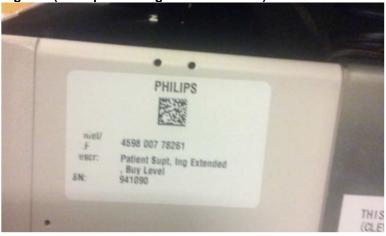
Figure1 (Example: six digit serial number):

There are two sets of serial number ranges that may be impacted. Serial numbers can be either five digit or six digit numbers. The patient support (couch) serial number can be found on a label located on the front closest to the gantry of the patient support (couch) cover. Refer to Figure 1 and Figure 2 for examples of serial numbers. Refer to Table 1 and Table 2 for list of affected patient support (couch).
