Urgent Field Safety Notice

SBN-CPS-2018-002

cobas e 801 syringe plunger issue

Product Name	cobas® 8000 modular analyzer series cobas e 801 module
Affected Instrument Part GMMI / Part No	PLUNGER (798-3203)
Instrument/System Affected	cobas e 801 module (GMMI 07682913001) from serial numbers 1601-01 to 18E6-10
SW Version	Not applicable
Type of Action	Field Safety Corrective Action (FSCA)

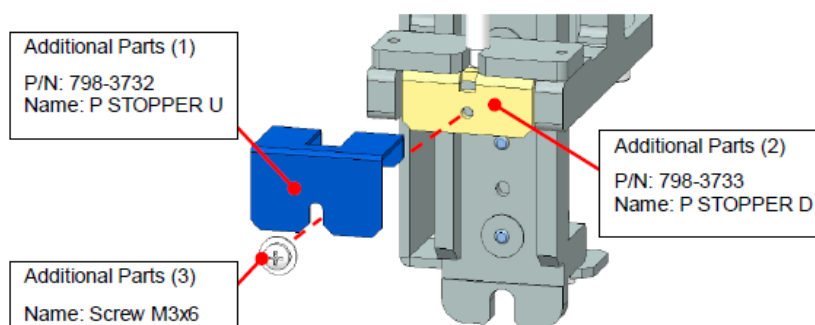
Depending on how the seal pieces are assembled it is possible that the plunger is mounted in a tilted position which applies mechanical stress to the plunger. In the worst case scenario during the **cobas e 801** initialization steps when the largest strokes happen, the plunger may crack leading to an impaired syringe function.

A mandatory installation of a syringe plunger guide for the R1, R2 and PW syringes is required for **cobas e 801** modules in the field, from serial numbers 1601-01 to 18E6-10, illustrated below:

Hardware modification kits (above seen additional parts) are already available in our warehouse.

The installation of the kit requires few minutes, if the instrument is available in [Standby] mode. The kit assures the correct positioning and movement of the referred syringe plungers and thus prevents the issue.

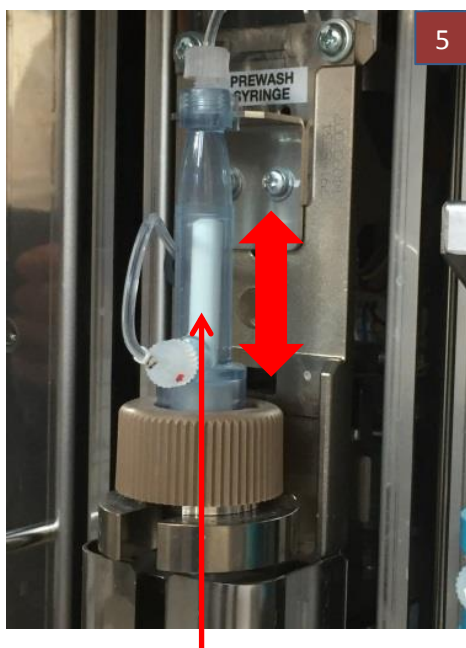
Pre-wash Syringe Plunger

- 5 To check the proper condition of the Pre-wash Syringe, open the **cobas e 801** module front cover. Visually verify that the white Plunger of the Pre-wash Syringe is moving up and down while the Pre-wash Unit is working. The stroke of the Plunger is not a performance relevant criterion.

If the Pre-wash Plunger is not moving, the **cobas e 801** module can not be used. In this case call Roche Customer Support.
