## Important Medical Device advisory - Update

### HeartMate 3™ Left Ventricular Assist System Catalog # 106524INT – HM3 LVAS KIT

May 25, 2018

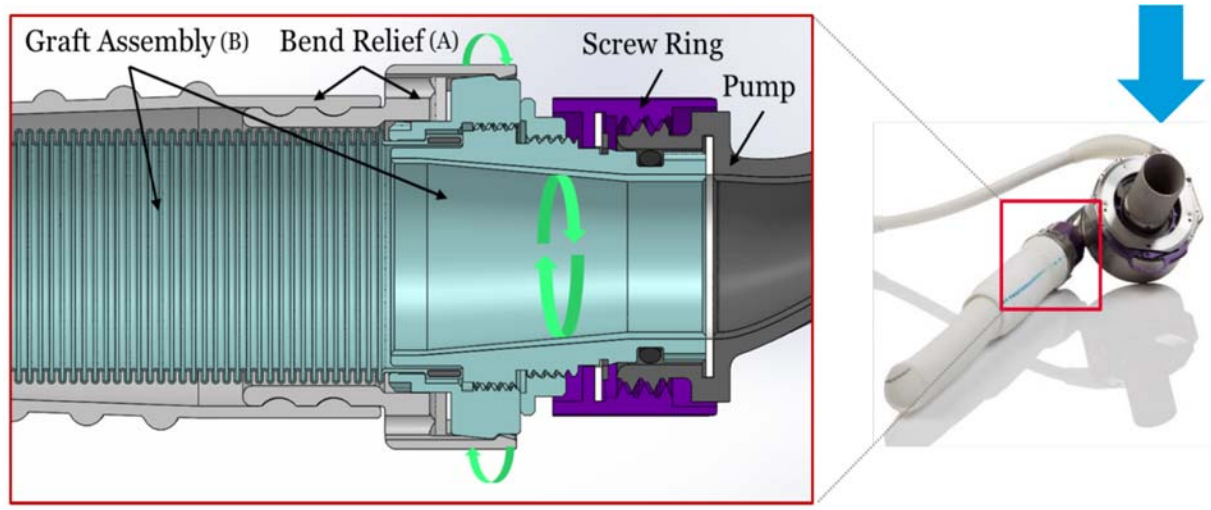
The HM3 is designed to allow for Outflow Graft connector rotation by the surgeon after connection to the pump, so that proper alignment of the Outflow Graft can be made during implantation without disconnecting the Outflow Graft connector from the pump. Appropriate tightening of the Screw Ring (see below) during implantation reduces, but does not eliminate, the propensity of the Outflow Graft connector to rotate. *In vivo*, normal forces can rotate the metallic Outflow Graft connector; if the rotation is in one direction only (instead of back-and-forth (clockwise/counter-clockwise)), then twist will accumulate in the graft. Accumulation of Outflow Graft twist can occur at any time point post-implantation. The twist may deform the Outflow Graft (a twist occlusion) and reduce or stop pump flow. The time course from the beginning of an accumulation of twist to an occlusion is unknown and may be variable among patients. Occlusion of the HM3 Outflow Graft often requires urgent surgical intervention.

During implant, when attaching the Outflow Graft to the Pump Cover, a clicking sound will be heard as the Screw Ring is tightened. Continue turning the Screw Ring clockwise until it comes to a complete stop and stops clicking. Firmly hand-tightening the Screw Ring may reduce the risk of Outflow Graft twisting by increasing the resistance to metallic Outflow Graft connector rotation. To avoid damaging the Outflow Graft assembly, do not use tools to tighten the screw ring. This updated information (see Appendix 1) will be incorporated into the Instructions for Use following regulatory approval in each geography.

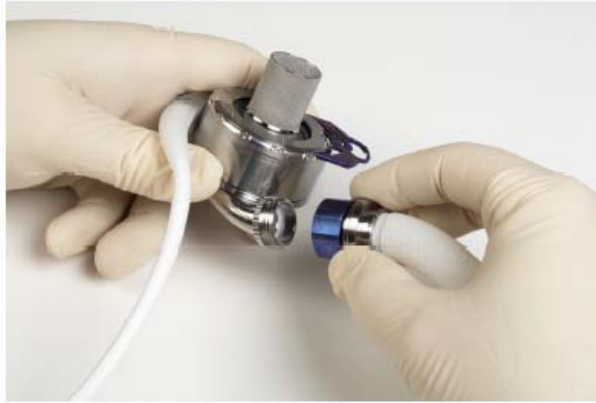
Figure 5.34 Attach the Graft

- Twisting of the Outflow Graft has been identified in some patients post-operatively. Occurrences of twisting have resulted in graft occlusion, thrombosis, and/or death. The accumulation of twist within the graft is related to rotation of the metallic Outflow Graft connector within the attached Outflow Graft Bend Relief connector.

1. Remove the thread protector from the Pump and the Outflow Graft. Using the Screw Ring, attach the Outflow Graft to the Pump Cover, turning the ring clockwise. You will hear a clicking sound as you tighten the Screw Ring (this is normal). Continue turning the ring clockwise until it comes to a complete stop and stops clicking. See **Figure 5.34**.

Firmly hand-tighten the Screw Ring to ensure sufficient resistance to Outflow Graft twisting. To avoid damaging the assembly, do not use tools to tighten the Screw Ring.

2. Verify that the graft is not twisted or kinked by checking the position of the black line on the graft above and below the bend relief. The line should be straight.
