URGENT - Field Safety Notice

Medical Device: MultiDiagnost-Eleva

Tilt actuator base unit

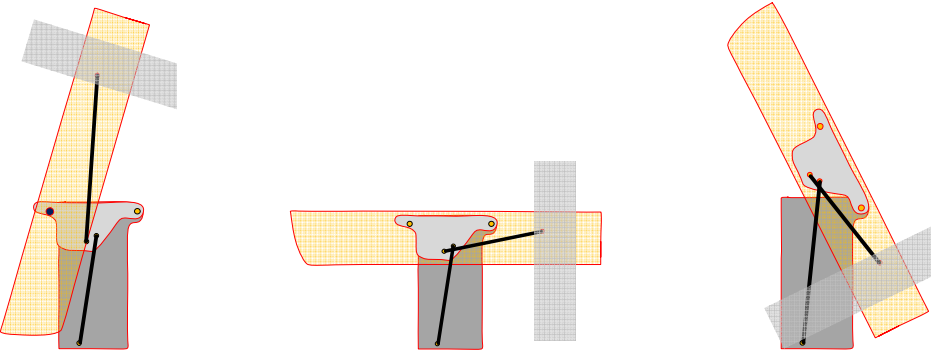
Philips has been reported instances in which the table of the Multidiagnost-Eleva (MD-Eleva) suddenly started to rotate from 0 to 90 degree (table arm down) with high speed. The cause of this unexpected rotation movement is related to an issue with the fixation of the upper and lower tilt actuator.

<p style="display: flex; justify-content: space-around; margin-top: 10px;"> Tilt towards - 90° Table horizontal Tilt towards + 90° </p> </div>																
<p>HAZARD INVOLVED</p>	<p>If the fixation of the actuator breaks off and if the point of gravity of the table is beyond its rotation point, the table starts to rotate uncontrolled to its + / - 90 degree end point, which potentially could lead to the patient falling off the table.</p> <p>During procedures, the system is remotely operated from the control room. In case of an uncontrolled rotation, there is a risk of injury for the patient, user or bystander standing in the vicinity of the system (e.g. the tube may hit the legs of that person). This might lead to harm that necessitates medical intervention for the person involved.</p>

ACTIONS PLANNED BY PHILIPS	<p>All possibly affected products in the field will be corrected by means of a field change order free of charge.</p> <p>A Philips representative will replace affected material on the upper and lower tilt actuator in the affected systems.</p> <p>You will be contacted by our local Philips representative to schedule this corrective action.</p> <p>This action will start effective April 2018.</p>
FURTHER INFORMATION AND SUPPORT	<p>If you need any further information or support concerning this issue, please contact your local Philips representative:</p> <p>0800 80 3000</p>
