URGENT FIELD SAFETY NOTICE

Loss of pacing and sensing following hardware failure, leading to absence of automatic detection of an arrhythmia requiring defibrillation shock therapy

FSCA identifier: CRM-SAL-2018-001

Affected devices: Limited subset of Platinum Implantable Cardiac Defibrillator (ICD) and Resynchronization Therapy Defibrillator (CRT-D) models : VR 1210, VR 1240, DR 1510, DR 1540, CRT-D 1711, SonR CRT-D 1811, CRT-D 1741, SonR CRT-D 1841, 4LV CRT-D 1744, 4LV SonR CRT-D 1844

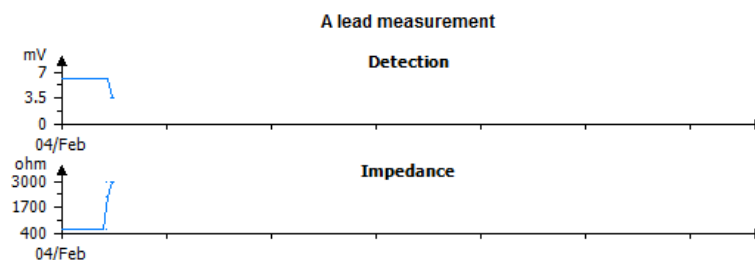
- a. The warning “Technical issue” indicates that overconsumption was detected. A steep decrease of the battery voltage may be visible on the battery curve.
- b. Warnings on high lead impedances in all cavities.
- c. Loss of sensing capability will result in flat EGMs and 100% pacing in the statistics.

Atrial lead impedance curve showing a sudden increase of the impedance

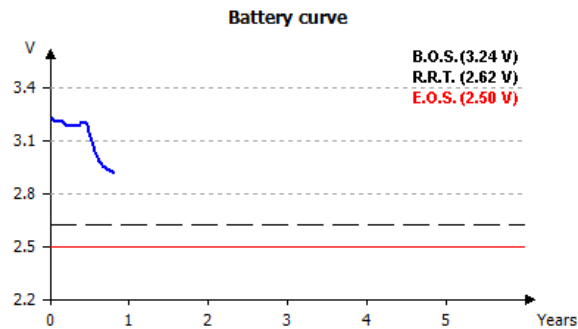
Battery curve showing a steep decrease of the battery voltage

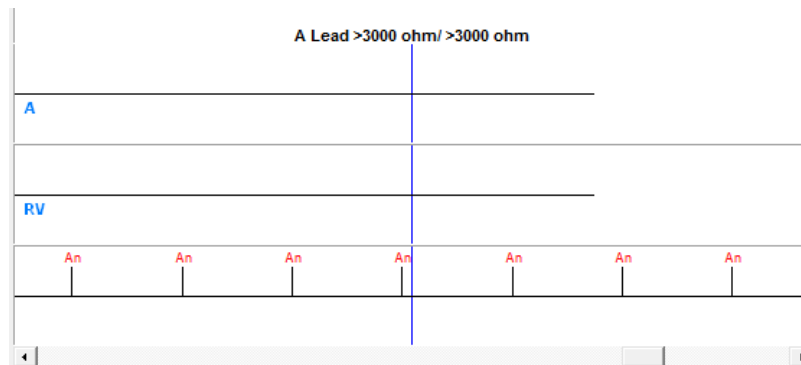
Flat EGMs

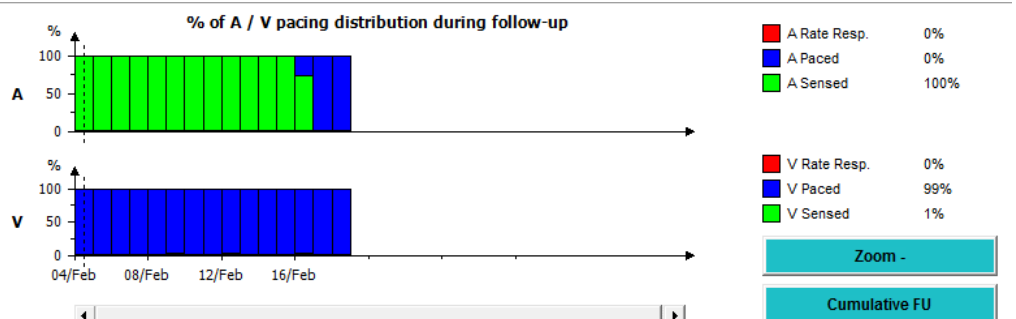
Statistics showing 100% pacing

When the failure described in this Field Safety Notice occurs, the device will no longer pace or sense. Due to the absence of sensing, the algorithm will send a pacing command for 100% of the cardiac cycles. The pacing spikes are not delivered due to the hardware failure, but 100% pacing statistics will be shown.
