July 23, 2018

Urgent Field Safety Notice: EZ1 Advanced XL, REF 9001492

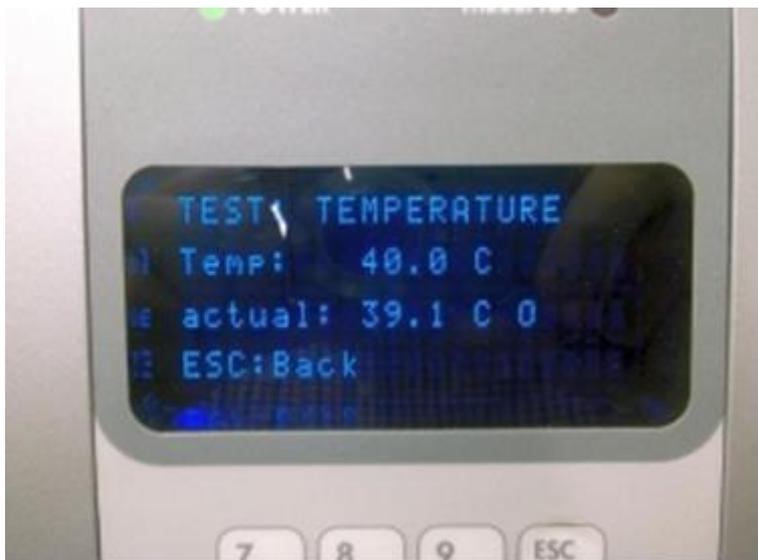
Observe the “actual” temperature which is displayed. This should rise to 40.0 C +/- 2 degrees within 2 minutes, and a “O” should be displayed next to the temperature value (Figure 1). In this case your instrument is NOT affected by this issue.

Figure 1. EZ1 Advanced XL display following a successful temperature check. Note specifically the “O” after the “actual” temperature

*In the event that the “actual” temperature does not rise to 40.0 C, an “X” continues to be displayed next to the temperature value, indicating that **your instrument is affected by this issue. In this case the nucleic acid eluate from the previous run should be rejected and the sample reprocessed.** Contact technical services to arrange a replacement of the faulty component.*
