URGENT FIELD SAFETY NOTICE

Potential for Unsuppressed Results using VITROS® 5600 Integrated Systems

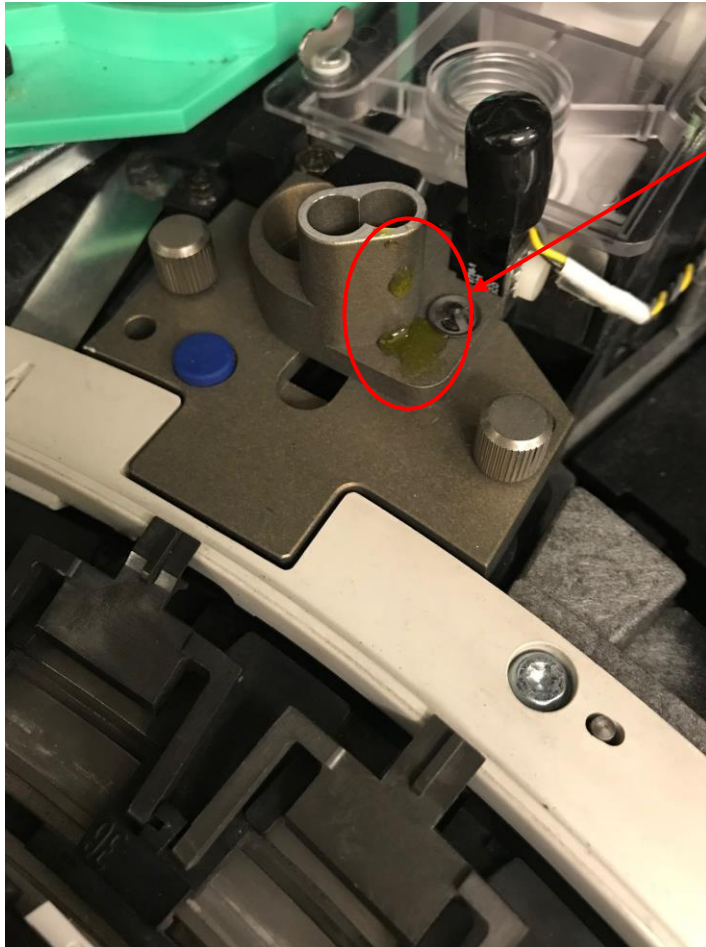
If these specific circumstances occur, the proboscis may deposit fluid on the tip locator or top surface of the slide and transfer sample fluid into the incubator.

The photograph below shows an example of fluid on the tip locator:

Fluid on
tip locator

- If you observe unexpected MicroSlide assay results for a sample associated with TE1-504 and/or TE1-594 condition codes, please do the following:
 - Inspect the tip locator to determine if sample fluid is present. Refer to example shown on page three.
 - If fluid is NOT observed, repeat all MicroSlide assays for the affected sample.
 - If sample fluid is observed on the tip locator or repeated results do not agree (i.e., incorrect results), contact the Ortho Care™ Technical Solutions Center for further assistance.
- Complete the Confirmation of Receipt form no later than **August xx, 2018**.
- Post this notification by each VITROS 5600 System in your facility or with the user documentation.
