## FIELD CORRECTIVE ACTION NOTICE

Leica M525 F20 Microscope System

FCA Identifier: CAPA-HER-MD-18-001

Enhancement of instructions for use and additional markings to prevent inadvertent tipping

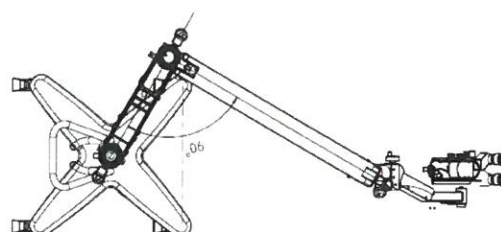
Figure 2: Top view of Leica M525 F20 Microscope

Intended correct positioning:

~ 90° between horizontal arm and swing arm

- You can continue to use the system pending availability of the enhanced user manual and the additional markings as described in Attachment 1:
  - Ensure that your Leica M525 F20 is positioned and handled with an angle of approximately 90° between horizontal arm and swing arm during surgery as well as during set-up and preparation (see Figure 2 and Attachment 1).

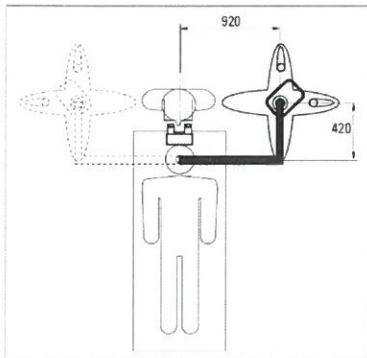
Figure A: Intended positioning - Option 1

The enhanced revision of the Leica M525 F20 instruction for use will describe the intended positions of the Leica M525 F20 in the OR as shown in Figure A and B below.

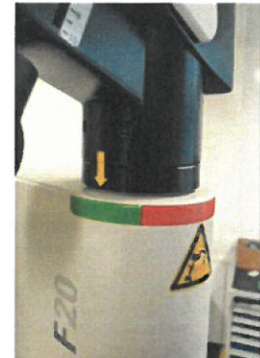
Figure C: Scale Indicator

An additional marking with a scale indicator and arrow as shown above in Figure C will assist Leica M525 F20 users to position the horizontal arm and swing arm with as intended with an angle of approximately 90°:

- The yellow arrow pointing to the green area shows that the device is set up as intended.
- The yellow arrow pointing to the red area shows that the device is not set up as intended and special care is needed to prevent inadvertent tipping when handling the device.

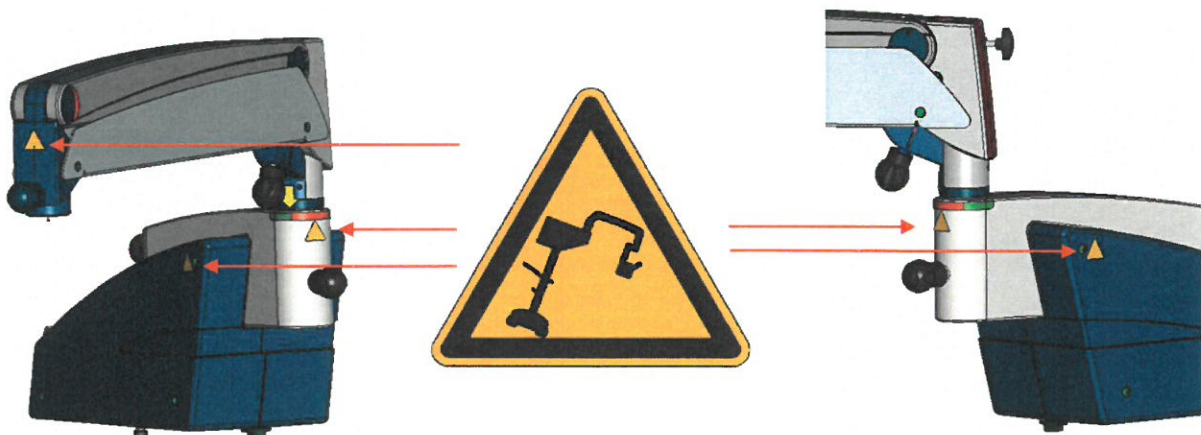
Figure D: Position of new Warning Label

Four additional warning markings (see Figure E) will be placed on the Leica M525 F20 to make users aware of tipping hazards when handling the device as shown below in figure D and F:
