INGENIO™ Family DR EL Pacemakers and CRT-Ps (92705305-FA) And Hydrogen Induced Accelerated Battery Depletion (92289212-FA)

Urgent Field Safety Notice

Subject: Field Safety Notice – High Battery Impedance May Initiate Safety Mode in INGENIO™, VITALIO™, and ADVANTIO™ pacemakers and INLIVEN™, INTUA™, and INVIVE™ cardiac resynchronization therapy pacemakers (CRT-Ps) (Boston Scientific Field Action Reference: 92705305-FA).

Subject: Field Safety Notice – Hydrogen-Induced Accelerated Battery Depletion in ACCOLADE™, PROPONENT™, ESSENTIO™, and ALTRUA™ 2 pacemakers and VISIONIST™ and VALITUDE™ cardiac resynchronization therapy pacemakers (CRT-Ps) originally communicated in September 2018 (Boston Scientific Field Action Reference: 92289212-FA).¹

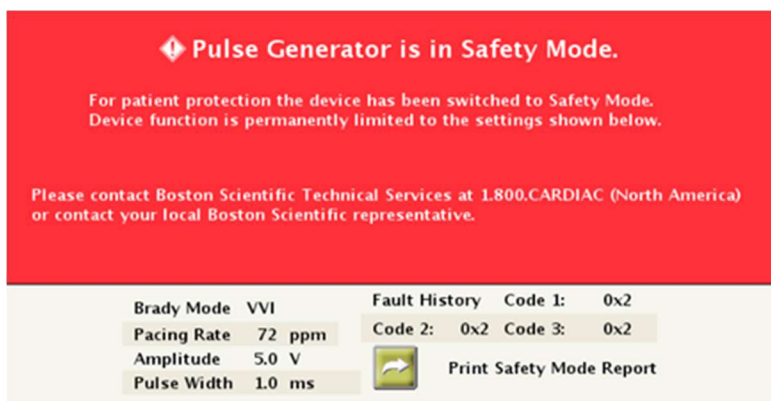
Boston Scientific has received reports associated with dual chamber INGENIO family pacemakers and CRT-Ps built with the EL battery (Appendix A), in which the devices transitioned to Safety Mode during interrogation attempts by either a programmer or a LATITUDE™ communicator. Investigation has shown that the EL battery impedance increases over time, based on implant duration and power usage. This increased battery impedance may cause a device to exhibit transient voltage decreases during periods of high-power consumption associated with telemetry communication via a programmer or a LATITUDE communicator. If the battery voltage drops below a minimum threshold during communication attempts, the device will temporarily halt telemetry, and a system reset will be performed. The battery voltage recovers and pacing function resumes within one (1) second; however, subsequent telemetry attempts may result in additional system resets due to the high battery impedance. If three (3) system resets occur within a 48-hour period, the device is designed to immediately enter Safety Mode to maintain back-up pacing with pre-defined, non-programmable settings (Table 1). There is no delay in resumption of pacing when the device enters Safety Mode. When a device is in Safety Mode, replacement is required.

Figure 1. Programmer Warning Screen for Safety Mode

2- Replacement. If a device enters Safety Mode, schedule replacement. Boston Scientific does not recommend general prophylactic replacement for affected devices. However, for individual patients, factors such as those listed above and shared decision-making may support consideration of early device replacement to mitigate unintended clinical impact(s) due to potential entry into Safety Mode prior to the Explant indicator. In these cases, the following guidance should be considered:
