Urgent Field Safety Notice

Software Distribution Network & Associated Programmers

Product Name	Model Number
CareLink™ 2090 Programmer	2090; All Serial Numbers
CareLink Encore™ 29901 Programmer	29901; All Serial Numbers

October 2018

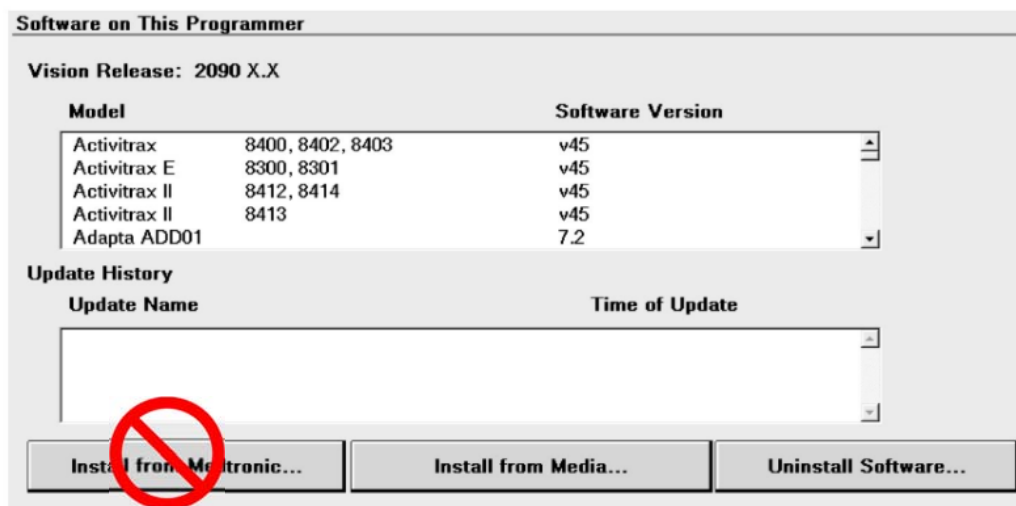
Programmer Software Screen

Do not attempt to update the programmer via the SDN. If you select the "Install from Medtronic" button, it will result in an unsuccessful installation of software because access to the external SDN is no longer available.

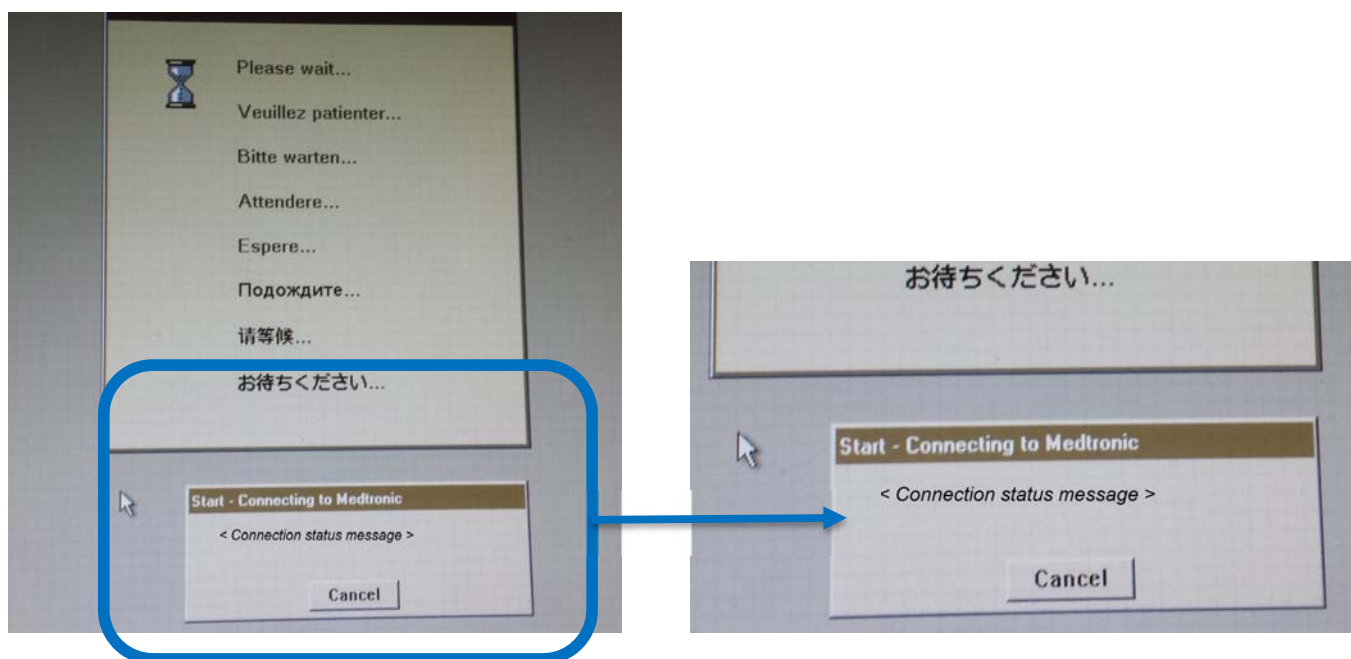
Several messages may be observed if installation of software from the SDN is attempted (e.g. "Install from Medtronic..."). See images below for example as to what will appear on the programmer display during the installation attempt. Below the larger "Please Wait" message will be a smaller window with a <connection status message> displayed; refer to highlighted area below. The connection status messages may alternate *between* "Connecting...", "Searching for Network...", "Logging in...", "Unable to connect to local network", and "Unable to connect to Medtronic". Since the SDN is no longer available, **the user should select "Cancel" to terminate the installation attempt.**

If the user cycles power on the programmer without first cancelling the installation attempt, upon power-up a count-down window will appear on the screen for approximately 30 seconds with "Yes" and "No" buttons. The user should select "No" to terminate the installation attempt and return to the Model Select screen. If the user selects "Yes" or does not respond prior to the 30-second time out, the programmer will attempt the installation again, and the process described above will repeat until the user either selects "Cancel" or selects "No" during the count-down window.
