URGENT FIELD SAFETY NOTICE

UniCel DxI 600 and 800 Access Immunoassay Systems and
UniCel Dx C 660i, 680i, 860i, 880i Synchron Access Clinical Systems

REF	SOFTWARE VERSIONS
UniCel DxI 600 Systems (A30260, A71460, A71461, A92060) UniCel DxI 800 Systems (973100, A71456, A71457, A84545, A25288, A25285) UniCel Dx C 660i, 680i, 860i, 880i Synchron Access Clinical Systems (A64871, A64903, A64935, A59102)	5.2, 5.3.0, 5.3.1

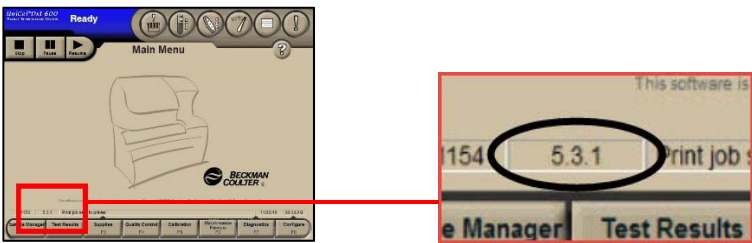
ISSUE:	<ul style="list-style-type: none"> Beckman Coulter has determined that UniCel DxI 600 and 800 system software versions 5.2, 5.3.0, and 5.3.1 contain a defect that has the potential to cause erroneous results when the instrument is operated while connected to an automation line (software versions 5.1 or earlier are not affected). Note: Your system software version is shown at the bottom-left of your system's Main Menu (See images below for location)
