**URGENT - Field Safety Notice  
Medical Device Correction**

**Ingenia Elition S, Ingenia Elition X**

**Unintended table movement after pressing 'stop-button'**

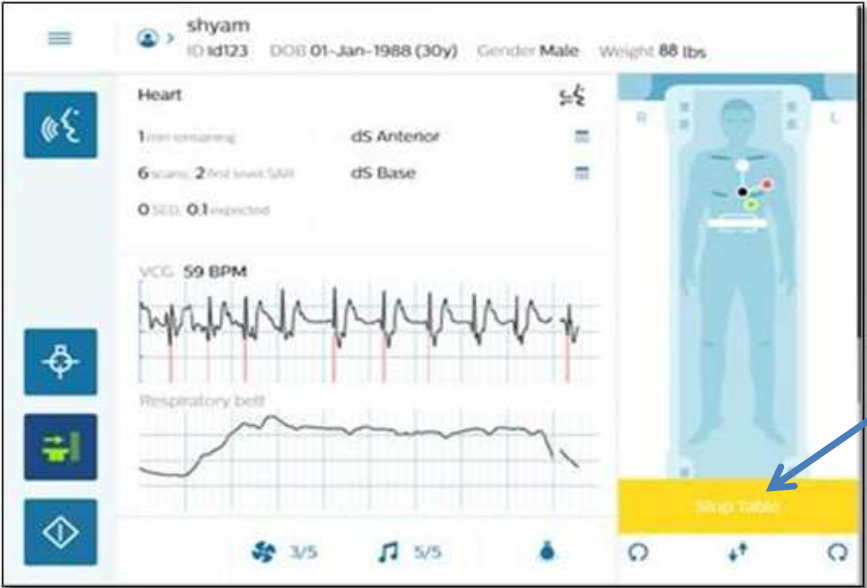
<p><b>AFFECTED PRODUCTS</b></p>	<p>Ingenia Elition S (781357), Ingenia Elition X (781358) MR systems</p>
<p><b>PROBLEM DESCRIPTION</b></p>	<p>Philips has become aware of a potential hazardous situation with the VitalScreen ‘Stop Table’ software button on the Affected Products (the yellow button on the right bottom corner as shown with the arrow below).</p> <p>During automatic tabletop movement, pressing and holding the ‘Stop Table’ button may lead to an unexpected restart of the table movement.</p>

<p>The issue does not occur when the Emergency Table Stop button or the tumble switch is used.</p> <p>Only a combination of the following factors may lead to unexpected table movement:</p> <ol style="list-style-type: none"> <li>1. User presses and holds the VitalScreen TTS button to initiate automatic tabletop movement (without the use of the tumble switch) and patient is moved into the bore.</li> <li>2. Patient is taken (partly) out of the bore (example use cases: to inspect the patient or administer contrast)</li> <li>3. To move the patient out, the VitalScreen TTS button is used again to initiate the second automatic tabletop movement</li> <li>4. The user wants to stop the table movement</li> <li>5. The user presses the VitalScreen ‘Stop Table’ button to stop the table movement.</li> </ol> <p>The issue does not occur when the travel-to-scanplane (TTS) button on the VitalScreen is used for the first time during an examination (bullet 1 in the preceding list).</p> <p>The issue was found during an internal assessment at a Philips Test facility, and no person was injured. The issue is not reported by customers.</p> <p>In addition the FCO solves following issues:</p> <ul style="list-style-type: none"> <li>- Software issues reported via customer feedback cases or internally reported issues.</li> <li>- The IfU and Technical Documentation (TD) were updated, amongst others, to be compliant with IEC60601-1-2 4th Edition (EMC).</li> </ul>

<b>HOW TO IDENTIFY AFFECTED PRODUCTS</b>	Ingenia Elition S (781357) and Ingenia Elition X (781358) MR systems, with software R5.5.0.0
<b>ACTION TO BE TAKEN BY CUSTOMER / USER</b>	<p>The user must follow the Instructions for Use to verify that no part of the patient's body, hair, clothing, cables or infusion lines can get trapped or injured by any part of the equipment. Additionally, the VitalScreen shows positioning guidance regarding arm supports and padding.</p> <p>The user should avoid the use of the yellow 'Stop Table' button on the VitalScreen. The user must always use the tumble switch or physical 'Emergency Table Stop' button for cases which require the table movement to stop.</p>
<b>ACTIONS PLANNED BY PHILIPS</b>	<p>Via FCO78100490 Service Pack 1 for R5.5.0 will be rolled out to the affected systems. With this Service Pack the 'Stop Table' software button on the VitalScreen will be removed.</p> <p>The additional items mentioned in the problem description are implemented.</p>
