URGENT - Field Safety Notice Medical Device Correction

Additional fixation (grip) of the ceiling speakers of the MR system

A problem has been detected in Philips MR systems that, if it were to re-occur, could pose a risk for patients or users. This FSN 781 00484 is intended to inform you about:

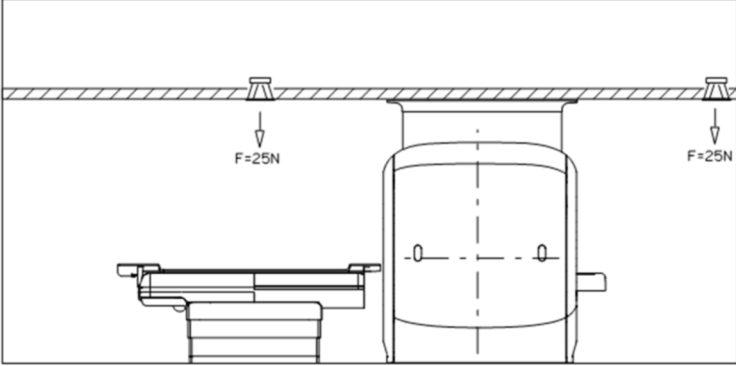
AFFECTED PRODUCTS	Intera, Omniva, Enterprise, Achieva, Achieva XR, Achieva Conversion, Panorama HFO, Ingenia, SmartPath to dStream, Multiva, Prodiva, MR-OR, MR-RT, MR-Linac, MR-Marlin systems
PROBLEM DESCRIPTION	<p>Philips MR systems are standard equipped with two ceiling speakers, positioned in the front and/or rear of the MR system. These speakers enable communication between the operator in the examination room and the patient and offer stereo music or ambient experience audio. These speakers are in most cases fixated in the suspended ceiling of the MR examination room according to the Philips service instructions. The Philips Planning Reference Data (PRD) prescribes the suspended ceiling must be strong enough to hold 25 N speakers.</p> <p>However in very rare cases, due to external influences (hospital facility maintenance, water leakage, degradation of speaker fixation) during the lifetime of the MR system, the ceiling speaker(s) could fall from their position and be pulled to the MR system by the magnetic field.</p>

HAZARD INVOLVED	<p>In case the ceiling speaker or ceiling tile with speaker drops down, it will get pulled to the MR system by the magnetic field. This potentially can result in:</p> <ul style="list-style-type: none"> - serious injury to a patient, operator or other persons in the examination room - damage to the MR system, e.g. covers <p>The severity of such event depends on where, how and if the ceiling speaker or tile hits a person or system.</p>
HOW TO IDENTIFY AFFECTED PRODUCTS	<p>All MR systems listed above have been delivered with two Philips speakers. The customer can visually check if these ceiling speakers are mounted in the ceiling.</p> <p>Note: At some customers, ceiling speakers are mounted to the wall with a wall mounting box, which does not present a similar risk. Therefore, wall-mounted speakers are out of scope for this notification.</p>

<p>ACTION TO BE TAKEN BY CUSTOMER / USER</p>	<p>Following checks/actions by the customer are recommended:</p> <ul style="list-style-type: none"> - Check if the speakers are mounted in the ceiling. - Visually check for signs of fixation degradation: e.g. water leakage, color changes of ceiling tiles, poorly positioned tiles. - In case of suspected insufficient fixation, do not correct the fixation yourself, but immediately contact your local Service/Philips representative.
