URGENT - Field Safety Notice

Medical Device Correction

Ingenuity TF PET/CT running software version 4.0.2 (4.0.0.26645) Software Issues

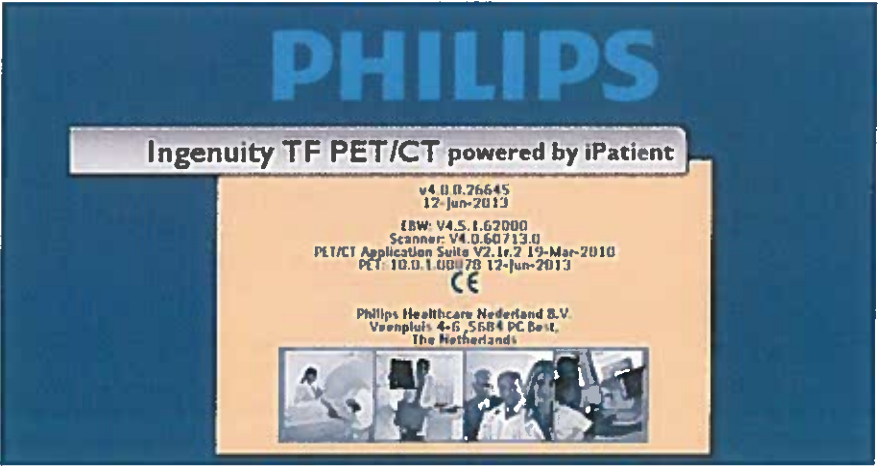
<p>need for radiopharmaceutical reinjection is also dependent on the half-life of the isotope being used.</p>
<p>HOW TO IDENTIFY AFFECTED PRODUCTS</p>	<p>The help screen will indicate "v4.0.0.26645" as pictured below:</p>

<p>ACTIONS PLANNED BY PHILIPS</p>	<p>Philips will be releasing Proactive Field Change Order (FCO) 88200515 to deploy software version 4.0.3 to correct the issues described above. This update will include both hardware and software.</p> <p>Your Philips Field Service Engineer will contact you to schedule the update. The software and hardware installation will take approximately 3-4 days, followed by 3 days of onsite support from your local Philips clinical applications specialist.</p> <p>Because of the software change, your custom site-specific exam cards will not be available on the system after the upgrade. The CT parameters for all custom CT and PET/CT exam cards can be saved via the Print & Text Tool in the Exam Card Manager prior to the upgrade. However, the PET parameters (including reconstruction protocol names that are linked to the custom exam cards) will not be exported and recorded. Please work with your Clinical Applications Specialist prior to the upgrade to develop a plan for recording the PET parameters for all custom site-specific PET/CT exam cards.</p>
