**Urgent Field Safety Notice**  
**Programmer Software Update**  
**Supporting the Micra™ Transcatheter Pacing System**

Model
2090 CareLink™ Programmer 29901 Encore™ Programmer CareLink Network Application Software 2491

January 2019

Medtronic reference: FA856

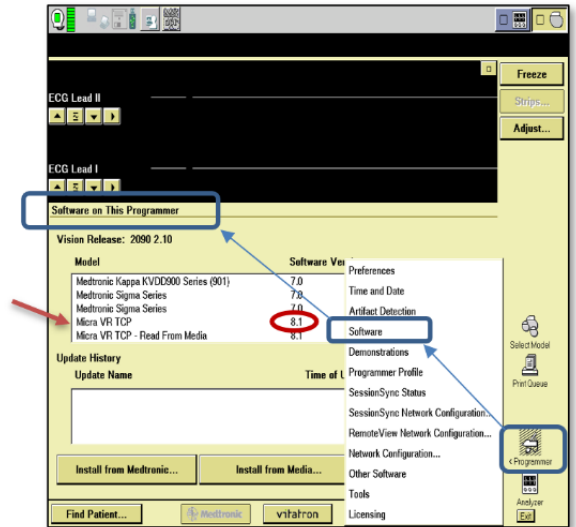
Image 1

Correct software: Micra VR TCP version 8.1 (or higher)

- Select Software (see image 1)
- Scroll through the list of available Software Models in the top selection box until you locate the Micra selection
- Verify the Software Micra VR TCP Version is 8.1

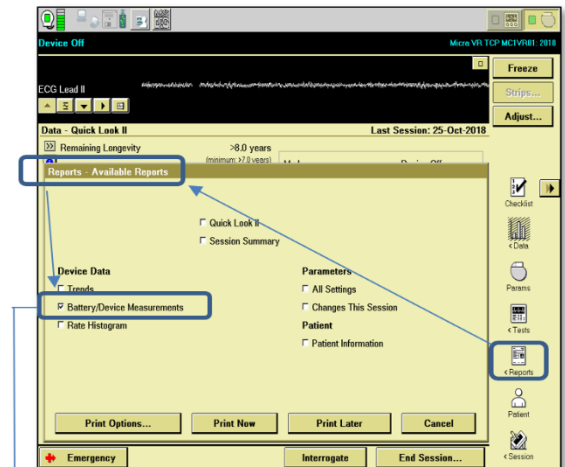
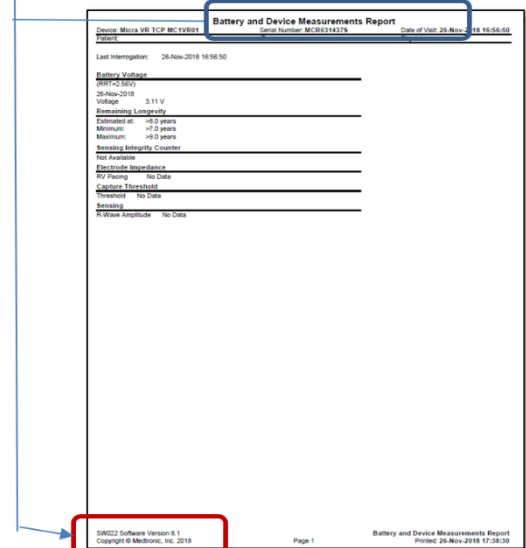
Images 2a and 2b

Any CareLink transmission completed after January 17, 2019 will report the updated remaining longevity estimate. For in-clinic patients who have been interrogated via a programmer, the clinician can view the Battery and Device Measurements Report (Images 2a and 2b) and verify that the Software Application Model ID located in the lower-left corner of the report indicates "SW022 Software Version 8.1".

- Select Reports (see image 2a)
- Select Battery/Device Measurements
- Click Print Now
- Verify the software version printed on the lower left-hand corner is "SW022 Software Version 8.1"
