URGENT – Field Safety Notice

Bent pedal of footswitch might cause interruption of live Fluoroscopy imaging or exposure.

A problem has been detected in the Philips MultiDiagnost-Eleva with Flat Detector and Allura Xper systems that, might intermittently lead to interruption of live fluoroscopy imaging or exposure.

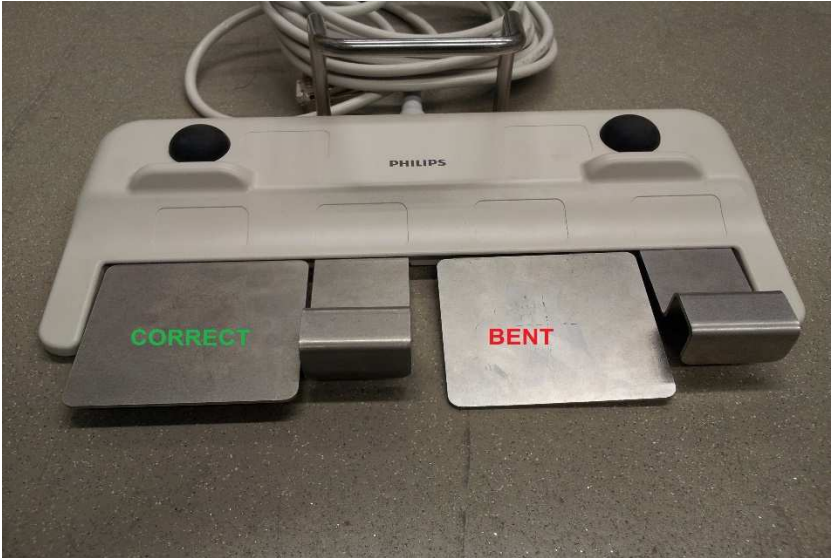
Philips noticed that due to a bent pedal of the footswitch, loss of image functionality is possible (intermittent or continuous inability of making live fluoroscopy images or exposures). The pedal may get bent when the footswitch is frequently used on an anti-fatigue mat or on a not flat surface or in the pedestal.

</div> <p><i>Left pedal is correct. Third pedal from left is bent. Distance to floor should be approx. 12mm (0,47inches).</i></p> <ul style="list-style-type: none"> • Do not use the footswitch on an anti-fatigue mat or in the pedestal. • Please ensure that all staff with access to the affected systems are informed of the content of this Field Safety Notice. • Include this Field Safety Notice together with the documentation of the system until the system has been corrected by Philips.

ACTIONS PLANNED BY PHILIPS	<p>The problem will be resolved by an update of the mechanical hardware of the Footswitch that will prevent that the pedals of the footswitch becoming bent.</p> <p>This mechanical hardware is available by March 2019.</p> <p>You will be notified by your local Philips representative to schedule a date for installation of this mechanical hardware update.</p>
FURTHER INFORMATION AND SUPPORT	<p>If you need any further information or support concerning this issue, please contact your local Philips representative: 0800 80 3000</p>
