**URGENT - Medical Device Recall  
IntelliVue MX40**

**Increased Battery Power Consumption and Absence of Low Battery Alerts**

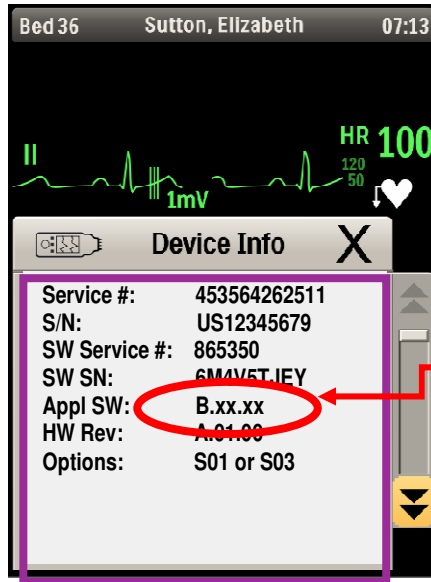
### Device Info Screen

Revision B software

Confirm Revision B software

<p><b>ACTION TO BE TAKEN BY CUSTOMER / USER</b></p>	<p>MX40 monitors can continue to be used while awaiting a software upgrade.</p> <p>Customers should maintain an adequate supply of fully charged batteries given the approximately 25% increased power consumption.</p> <p>Switch to continuous or manual SpO<sub>2</sub> measurements if your unit is using automatic measurement mode.</p>
<p><b>ACTIONS PLANNED BY PHILIPS</b></p>	<p>Philips Healthcare will release a software revision, which will correct both issues. Philips will contact you to arrange for software correction.</p>
<p><b>FURTHER INFORMATION AND SUPPORT</b></p>	<p>If you need any further information or support concerning this issue, please contact your local Philips Representative:</p> <p><b>0800 80 3000</b></p>

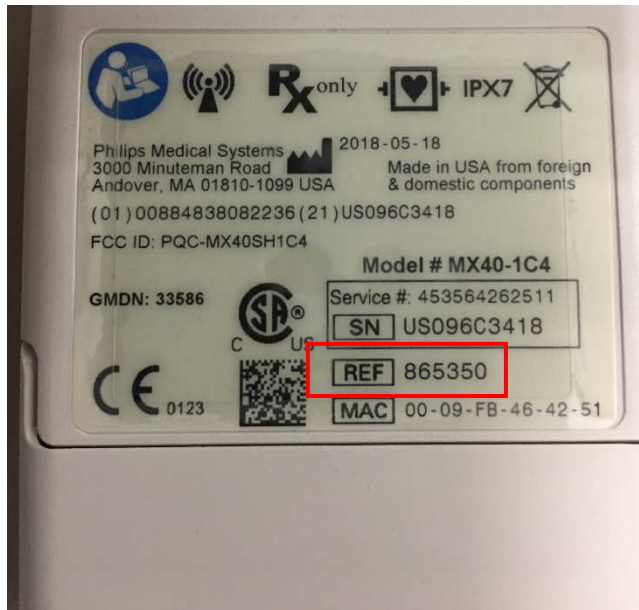
#### Problem 2 / Step 1

Confirm 865350 or 865351 part number ("REF")

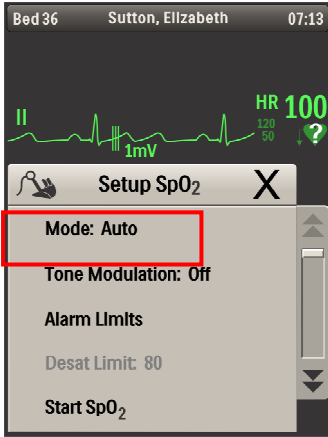
<p><b>Problem 2 / Step 3</b> Confirm that MX40 includes SpO<sub>2</sub> operating in automatic mode</p>
