Urgent Field Safety Notice **O-arm™ 1000 Imaging System**

May 2019

Medtronic reference: FA870

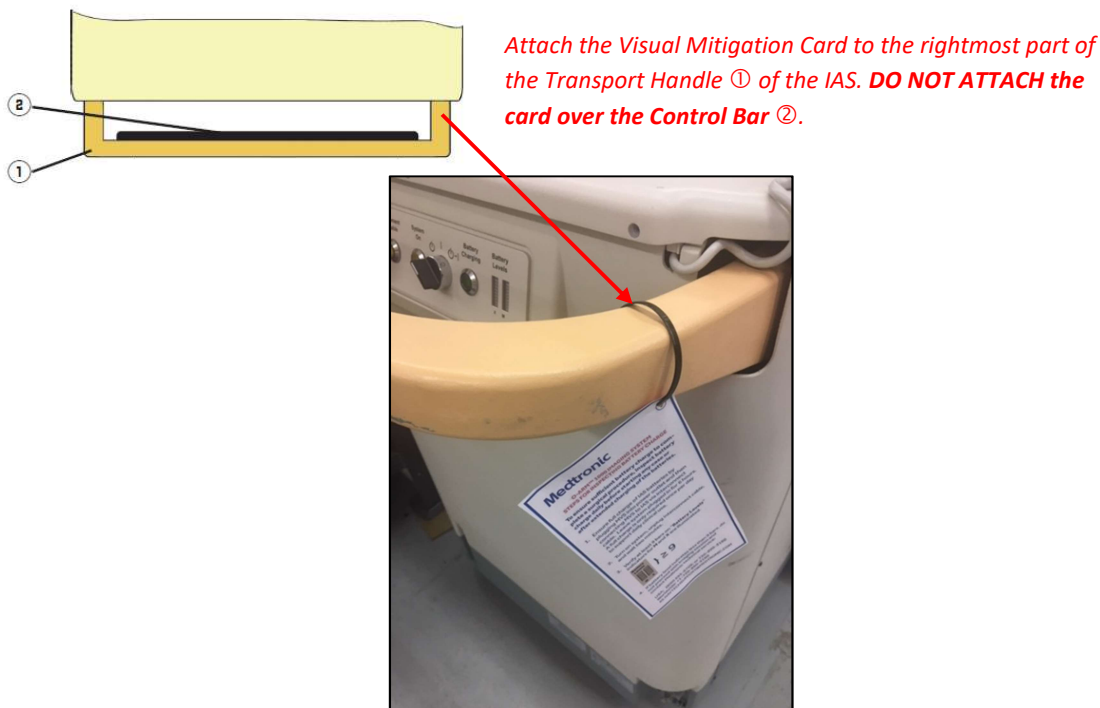
- 1) Attach the Visual Mitigation Card to the IAS of your O-arm™ 1000 Imaging System, as illustrated in the image below, and follow the directions as noted.

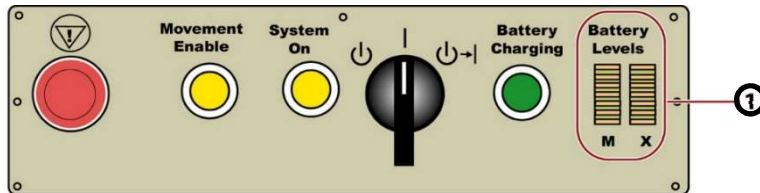
FIGURE 1

Battery Level Indicators: On the IAS Power Control Panel shown in Figure 1, the two columns of yellow LED lights (①) indicate the battery levels for the motion batteries (**M**) and the X-ray batteries (**X**). See “Battery Charge Level Indicators” in the user manual for more information about battery charge levels represented by the scrolling LEDs. See “User Performance Checks” in the user manual to ensure proper operation of the machine.

- While the Image Acquisition System (IAS) is turned on, unplug the interconnect cable and wait two minutes.
- Check the battery charge indicators on the power control panel.
- Verify that the **X** and **M** battery level indicators have at least 9 out of 10 bars illuminated to ensure sufficient battery charge to accomplish the procedure.
- If battery level indicates less than 9 bars, do not proceed with imaging session and contact Medtronic technical service +1-720-890-3160; or via email to RS.NAVTECHSUPPORT@MEDTRONIC.COM.
