URGENT - Field Safety Notice

Medical Device Correction

Ingenuity CT, IQon Spectral CT, iCT, Brilliance 64 CT, Ingenuity TF, Vereos Step and Shoot Incorrect Image Phase Labeling

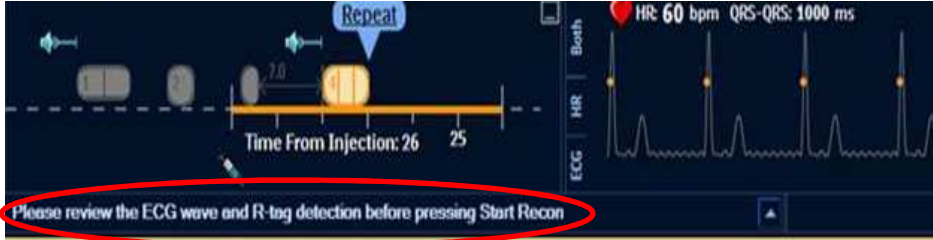
<p><i>4.x Graphical User Interface example</i></p> <ul style="list-style-type: none"> How to avoid in 4.x: Wait until the ECG strip is at the top of the acquisition window to starting the reconstruction.

<p>HOW TO IDENTIFY AFFECTED PRODUCTS</p>	<p>Determine whether you have a potentially affected system, then determine your AFFECTED PRODUCTS software version.</p> <p>To identify the software version of your product: Click the "Help" button Select "About" and the software version is then displayed Software versions 4.x, 3.x, and 2.x are potentially affected</p>
<p>ACTION TO BE TAKEN BY CUSTOMER / USER</p>	<ol style="list-style-type: none"> When performing a Step and Shoot acquisition with phase tolerance selected, images may be reconstructed identically (a single phase), but are labeled as different phases. This occurs when "Start Final Recon" is selected prior to display of the ECG wave at the top of the acquisition window. <ul style="list-style-type: none"> Reconstructed phases display as identical in online reconstruction, but reconstruct correctly during offline reconstruction. This occurs when the user clicks 'Start Final Recon' prior to the Console/Host receiving the ECG wave.

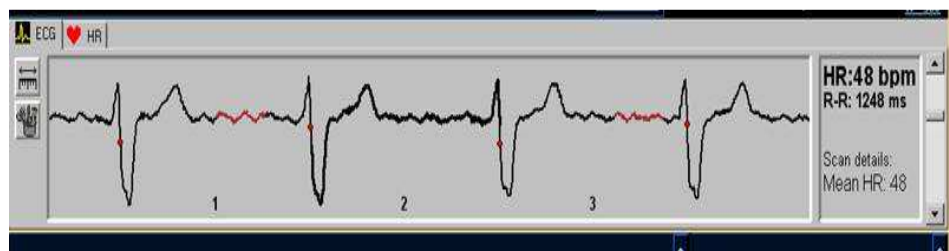
3.x Graphical User Interface example

This issue affects all systems listed above (with the exception of Vereos) with 4.x software and all iCT systems with 3.x software. Images can be reconstructed with phase tolerance by performing an offline reconstruction of the raw data. No patient rescan is required.

- How to avoid in 3.x: Wait until the ECG strip is visible at the bottom of the acquisition window to starting the reconstruction.

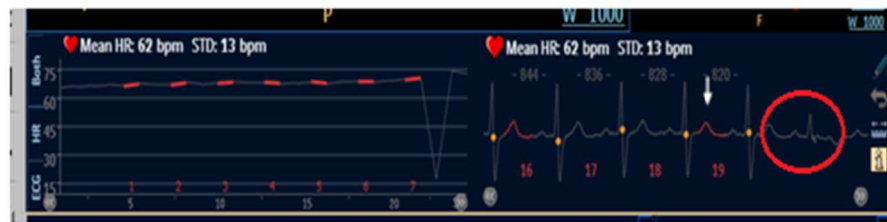
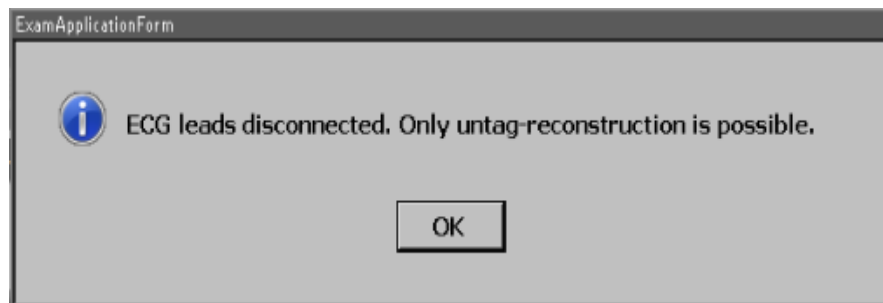
- This can occur with version 4.x software

- Should this occur, the user will receive the following console message:

- Images will be incorrectly labeled as if phase tolerance has been applied, however, the images will be reconstructed without phase tolerance.
- How to avoid: Ensure that the leads are securely attached to the patient prior to starting the acquisition and the length of table travel allows the leads to remain securely attached through acquisition completion. In the event of an application crash, there is no way to avoid the issue.
- When this issue occurs, images may still be used but are not labeled with the correct ECG phase. If images with phase tolerance are needed, a rescan may be required.
