Urgent Field Safety Notice

SBN-CPS-2019-015

CPS / Serum Work Area Systems

Potential malfunction in high pressure solenoid valves

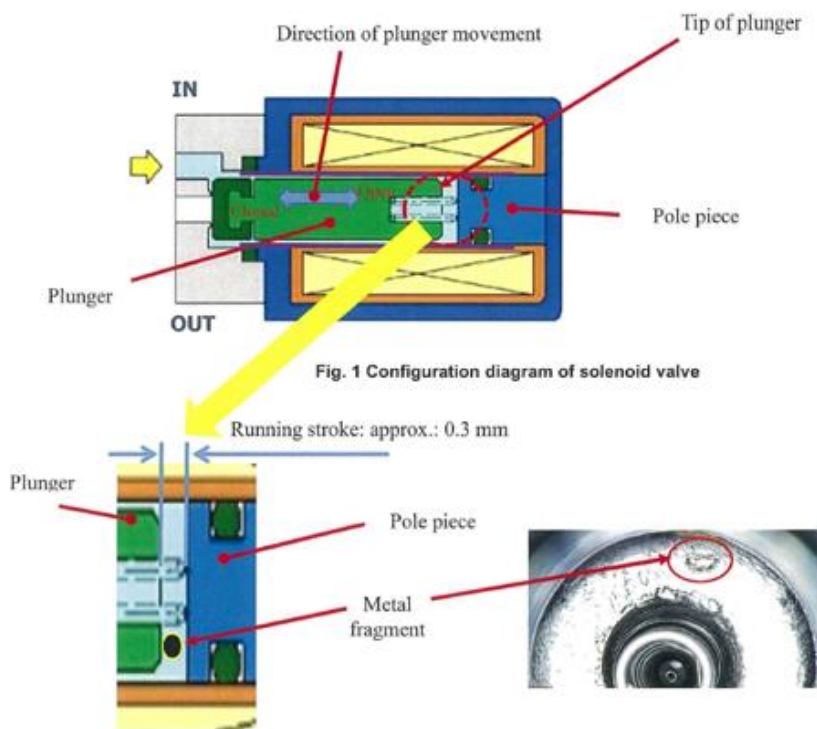
The root cause is related to metallic fragments peeling from the plunger in the solenoid valve. This metal fragment may prevent proper plunger movement and accordingly lead to potential malfunctioning of the solenoid valve opening/closing functionality (solenoid valve totally open and solenoid totally closed mode).

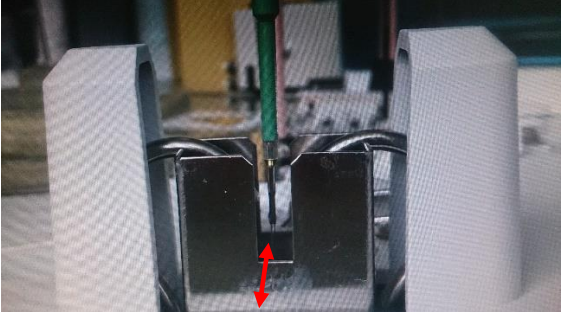
<p>jet of liquid leaving probe</p>
--	---

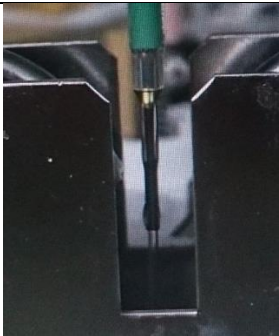
<p>constant jet of liquid for approx. 1 sec</p>

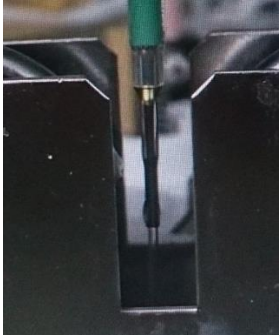
<p>constant jet of liquid for approx. 1 sec</p> </div>

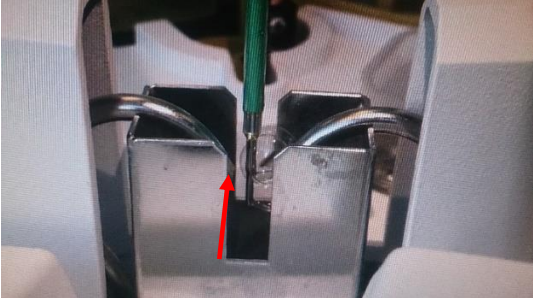
<p>Foam at end of reagent probe</p>
---	--

<p>Ok: a regular repeated jet of liquid is ejected from reagent needle into wash station for approx. 1 sec, then a pause with no liquid for approx. 1sec, then cycle starts from the beginning</p>	<p>Not ok:</p> <ul style="list-style-type: none"> - no jet of liquid, - air bubbles, foam - constant, not interrupted flow coming out of reagent probe
--	---

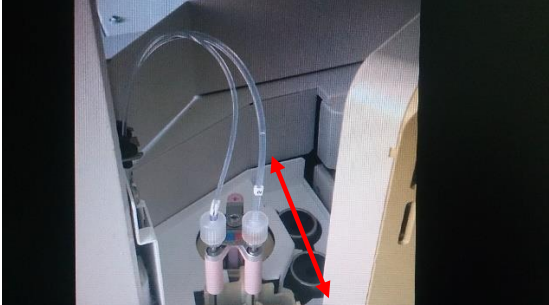
<p>air bubbles are observed frequently</p>
---	---

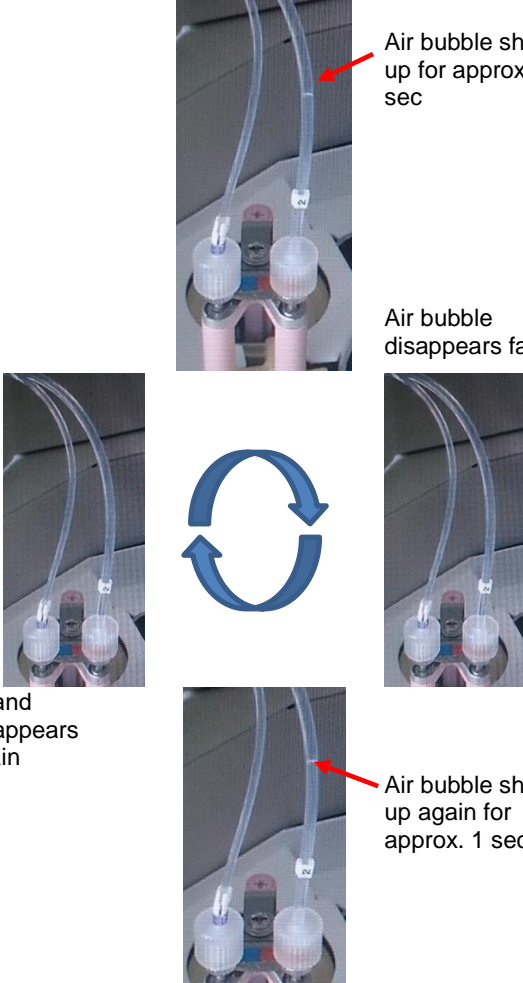
<p>Air bubble shows up for approx. 1 sec</p> <p>Air bubble disappears fast:</p> <p>... and disappears again</p> <p>Air bubble shows up again for approx. 1 sec</p>

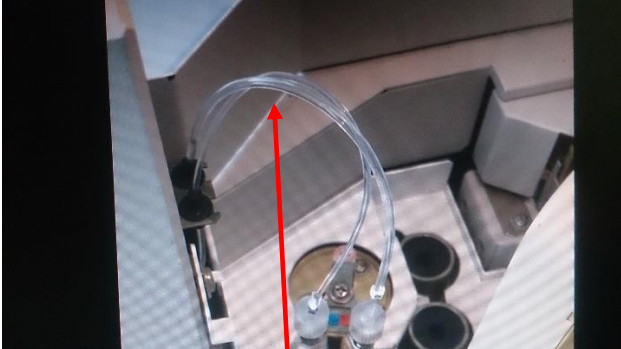
<p>Irregular, large air bubble in right tubing of pre-wash sipper probes</p>
<p>Ok: pre-wash sipper probe washing is checked by observation of the tubings connected to both probes: the right tubing must show a small air bubble popping up regularly from the probe, i.e. appearing and disappearing on a regular time scale</p>	<p>Not ok:</p> <ul style="list-style-type: none"> - large air bubble(s) in tubing, - irregular air bubbles, foam, - no air bubble at all.
