# Urgent Field Safety Notice

## SBN-CPS-2019-017

## AssayTips with abnormal internal structure used on cobas e 801

<b>Product Name</b>	<b>AssayTip/AssayCup tray</b>
<b>GMMI / Part No</b>	05694302001
<b>Instrument/System Affected</b>	<b>cobas e 801 module</b> <b>cobas e 801 analytical unit</b>
<b>SW Version</b>	Not applicable
<b>Type of Action</b>	Field Safety Corrective Action (FSCA)

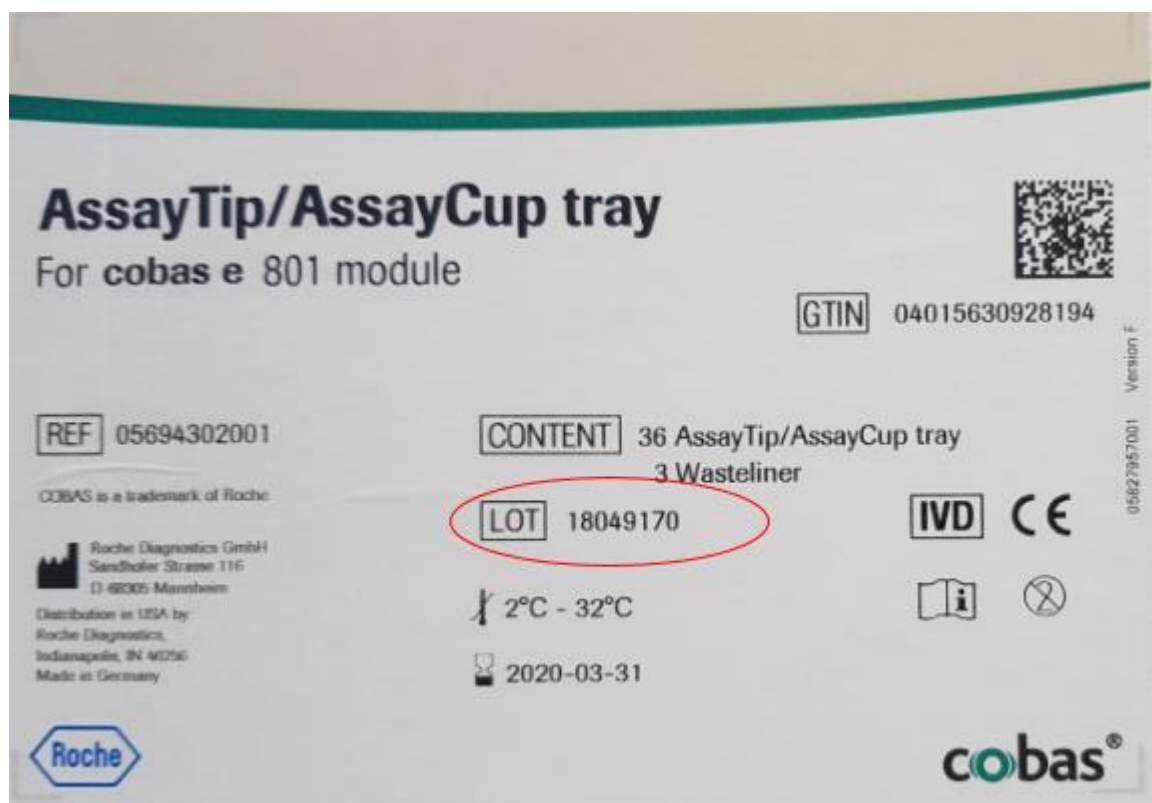
**Figure 2:** Example of a lot number printed on the AssayTip/AssayCup tray box

- Customers must check if they received affected AssayTips/AssayCup tray lots. Please compare your lots to the list of lot numbers provided (attached to this FSN).
- Customer must stop using the affected AssayTip/AssayCup tray lots and must discard the affected products locally.
- Customers are advised to also check the lot numbers of the trays placed on the instruments.
- In case that discrepant results are suspected during use of the affected lots, appropriate patient re-testing may be advisable, taking into account the patients' medical history and clinical examinations.

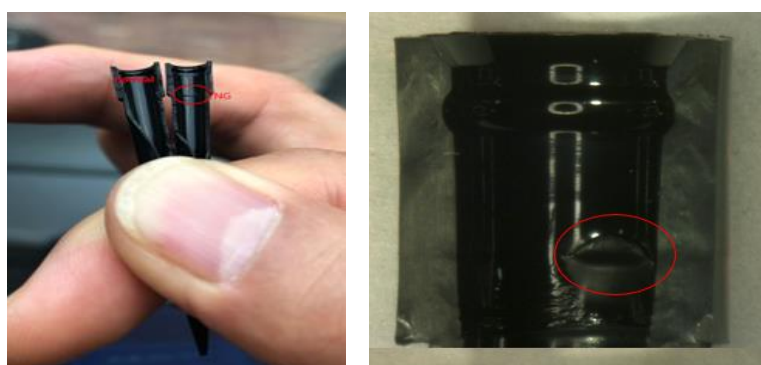
- Due to the abnormal internal structure, there might be a not optimal fit of the AssayTip with the sample probe. Thus, insufficient sample volume could be pipetted.
- Discrepant results without alarm message and/or flag cannot be excluded. Typically, low results of several consecutive measurements may occur.
- AssayTips with abnormal internal structure are likely to be found in groups in the tray (i.e. typically not a single isolated AssayTip with abnormal internal structure. Not all AssayTips from the affected lots are out of specification.

**Figure 3:** Examples of cut AssayTips with abnormal internal structure. The AssayTip includes a burr marked by a red circle.

An error affecting certain cavities of the production molds occurred in part of the production lines at our external supplier. This error led to the production of AssayTips with abnormal internal structure. The supplier has taken immediate corrective action in order to avoid re-occurrence of this issue. Current production is not affected by this error.

- The external supplier has identified the root cause and has immediately taken corrective action to avoid re-occurrence of this issue.
- Roche Diagnostics have stopped distribution of the affected AssayTip/AssayCup tray lots
