Urgent Field Safety Notice

Prismaflex Control Unit FA-2019-050 Device Correction

October 2019

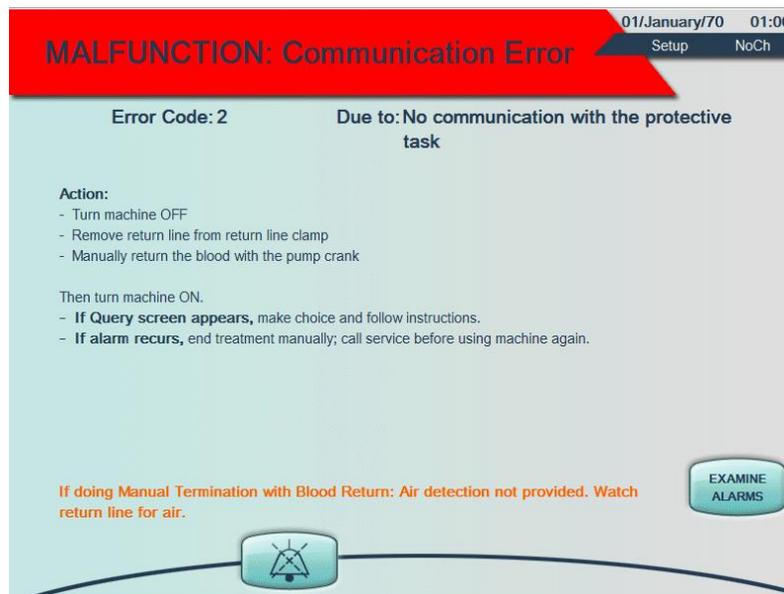
The following actions occur during a communication error alarm:

- The Prismaflex control unit enters a “safe state” by stopping all pumps and closing the return line clamp. Treatment is suspended. The patient’s blood does not circulate through the blood flow path.
- Red flashing light
- Recurring high-pitched sound of 10 sound pulses repeated approximately every 8 seconds until muted.
- Malfunction screen appears on the display as pictured below. The instructions to the user are the same for all error codes.

1. Operators may continue to safely use the Prismaflex control units until the upgrade is performed. If a communication error alarm does occur, follow the instructions presented on the graphical user interface and/or in the operator's manual. Please reinforce the importance to manually return the extracorporeal blood to the patient, and re-train users on this process, outlined in the operator's manual, if necessary.
