URGENT MEDICAL DEVICE CORRECTION**September 10, 2019****To:** Hospital/Surgeon Name**Affected Product:** ROSA Brain 3.0

Medtech S.A - Zimmer Biomet - is initiating a medical device Field Safety Corrective Action for ROSA Brain 3.0 products. This notice informs you of the issue and the corrective actions Zimmer Biomet is taking.

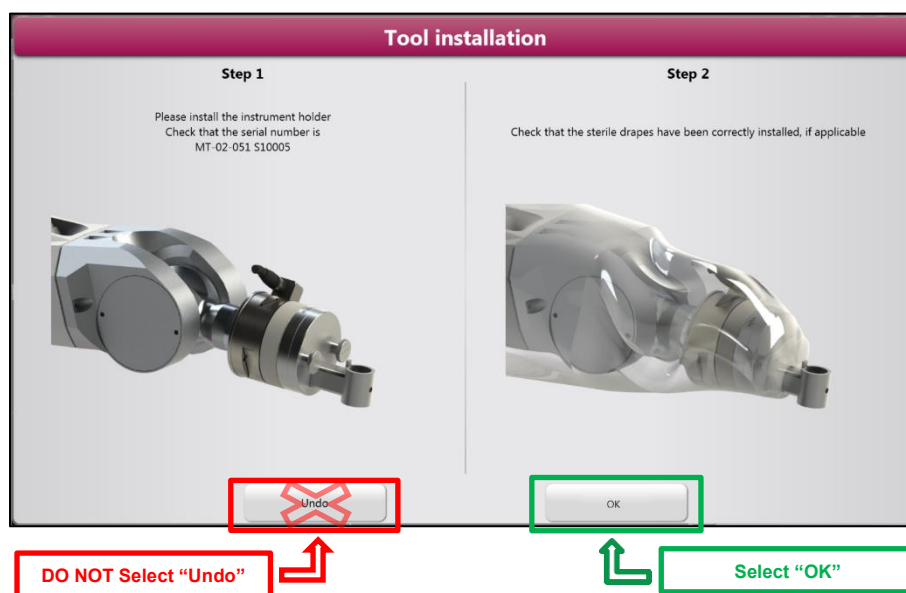
After the registration of the patient within the ROSA Brain 3.0 device, the issue may occur only in the guidance mode (e.g. when the robot arm is on trajectory), when the user selects the optical distance sensor and sends the robot arm on each entry point, and then selects the instrument holder. In such case, the use of the "Undo" button in the Tool installation panel will result in the issue due to a software anomaly.

- Once you select the instrument holder, if you would like to Undo your action :
 - DO NOT select "Undo"
 - Select "OK"

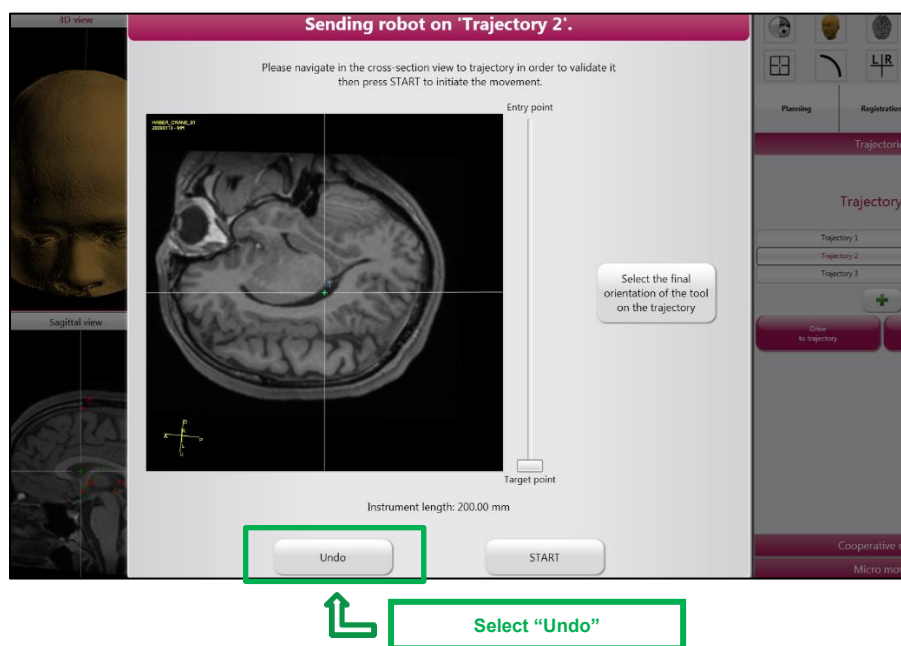
- In the next frame, select Undo

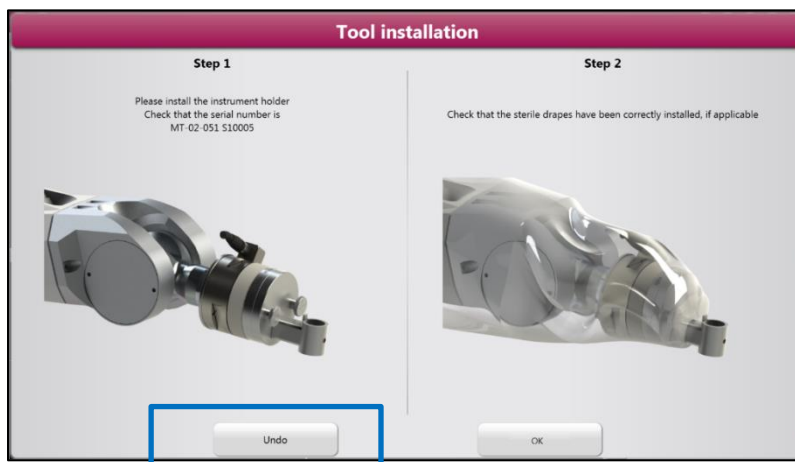
3. Installation of the instrument holder on the robot arm
4. Clicking undo on the tool installation frame

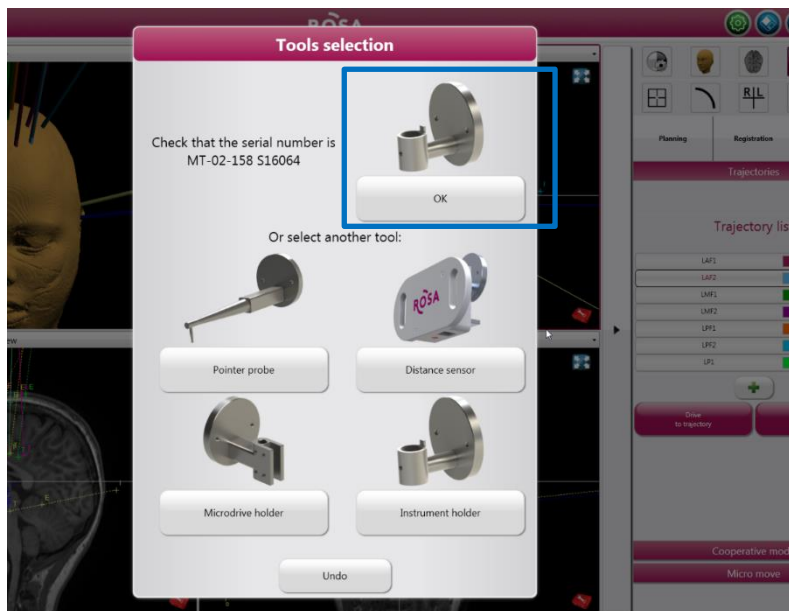
5. Choosing drive to a trajectory, then re-selection of the current instrument holder and drive to the trajectory

If the above listed steps are performed, the instrument holder may be sent on a trajectory that is not within the intended target.
