FSN79500527

September 2019

URGENT – Field Safety Notice

Philips S7-3t & S8-3t Transesophageal (TEE) Transducers Temperature Display Issue

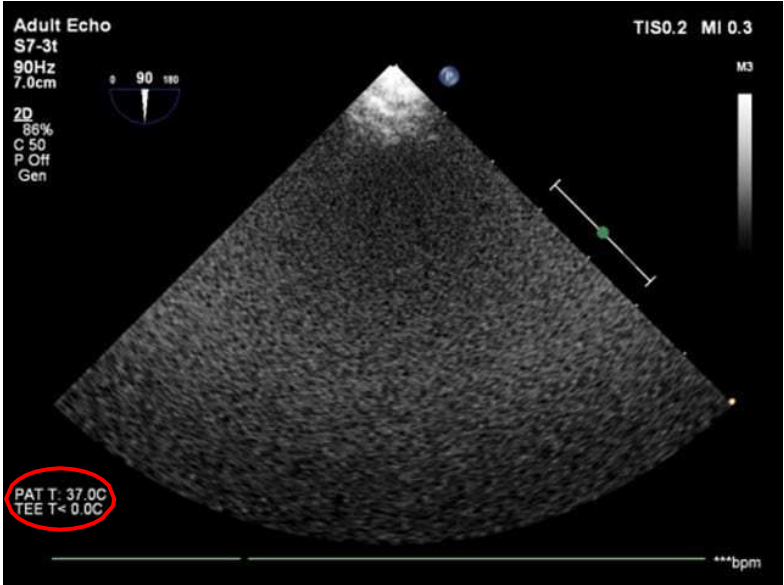
AFFECTED PRODUCTS	S7-3t & S8-3t Transesophageal (TEE) Transducers
PROBLEM DESCRIPTION	A small number of S7-3t and S8-3t TEE transducers were not properly programmed during manufacturing, as a result the system is unable to correctly measure the temperature on the distal tip of the transducer. EPIQ, Affiniti and iE33 systems will show the transducer temperature (TEE T) as <0.0C (<32.0F) on the display. HD11 and CX50 systems will show the transducer temperature (TEE T) as <37.0C (<98.5F) on the display. This issue will result in affected transducers not initiating auto-cool during use, when the transducer distal tip temperature exceeds 41.0°C (105.8°F).
HAZARD INVOLVED	Potential burn of esophageal tissue if the affected TEE transducer distal tip temperature exceeds 42.5°C (108.5°F), and auto-cool is not initiated.
HOW TO IDENTIFY AFFECTED PRODUCTS	<p>The affected S7-3t and S8-3t TEE transducers can be identified by connecting them to an EPIQ, Affiniti or iE33 system, and checking the transducer temperature (TEE T) that appears on the display when enabled. Affected transducers cannot be detected using HD11 or CX50 systems. See instructions below for each system.</p> <p><u>For EPIQ, Affiniti, & iE33 systems</u></p> <ul style="list-style-type: none"> • Connect the transducer to the system and ensure that it is secure and locked. • If the preset is not already selected by default, select it as follows: <ul style="list-style-type: none"> ○ S7-3t - Adult Echo, or ○ S8-3t - Pediatric. • Find the transducer temperature (TEE T) that appears in the lower left corner of the display. • If the transducer temperature on the display shows TEE T <37.0C (<98.5F), then the transducer was properly programmed, and no actions are required. • If the transducer temperature on the display shows TEE T <0.0C (<32.0F), then the transducer was not properly programmed (see image below), discontinue using the transducer and contact your local Philips representative. • If the transducer temperature (TEE T) does not appear in the lower left corner of the display, follow the instructions below to enable it: <p>EPIQ & Affiniti</p> <ul style="list-style-type: none"> • Swipe to the second touch screen • Touch Temp Display to display the temperature display <p>iE33</p> <ul style="list-style-type: none"> • Display the Preset/Transducer touch screen by touching Preset/Transducer • Touch Temp Display to display the temperature display

<p>For HD11 & CX50 Systems</p> <ul style="list-style-type: none"> Discontinue using the transducer immediately and contact your local Philips representative for support.
<p>ACTION TO BE TAKEN BY CUSTOMER / USER</p>	<p>If you have an EPIQ, Affiniti or iE33 system, verify that all your S7-3t and S8-3t TEE transducers are programmed properly by connecting them to the system, checking the transducer temperature (TEE T) on the display, and following the instructions provided on this letter.</p> <p>If you determine that your transducer is not properly programmed, discontinue using the transducer immediately and contact your local Philips representative to schedule an appointment with a field service engineer.</p> <p>If you have an HD11 or CX50 system discontinue using the S7-3t and S8-3t transducer immediately and contact your local Philips representative for support.</p> <p>Please complete the included reply form on the last page and return to Philips as soon as possible via email to customercare.ch@philips.com</p>

<p>ACTIONS PLANNED BY PHILIPS</p>	<p>Philips will resolve the issue by replacing the affected transducers at no cost.</p>
<p>FURTHER INFORMATION AND SUPPORT</p>	<p>If you need any further information or support concerning this issue, please contact your local Philips representative: 0800 80 3000</p>
