Valence, November 18th 2019

Ref. AMPLITUDE: COMP-1044

Objet : **Urgent FIELD SAFETY NOTICE - Advisory Notice**
OPTIMAL[®] stem – Locking version

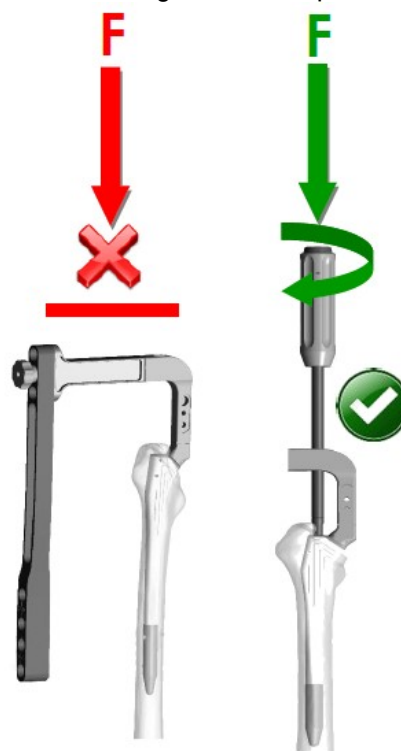
1 STEM IMPACTION AND ORIENTATION

When implanting the stem, **do not impact the frame while it is mounted on the stem** as this may jeopardise the **alignment of the drilling barrels (drill bits) with the holes in the stem**.

In cases where the recommendations would not be followed, there is a risk that the OPTIMAL[®] stem may be drilled beside the locking holes.

The frame **must be disassembled** after the trials on the back table and re-assembled after stem impaction. **Striking force should only be applied through the provided impactor**.

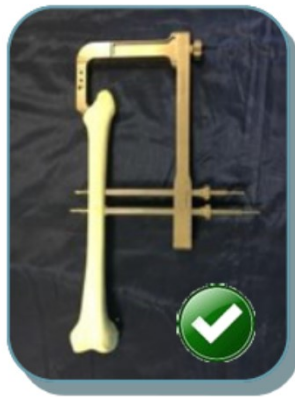
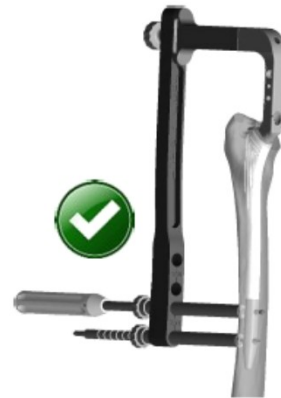
2 USE THE TWO DRILL BITS TO MAKE THE HOLES
AVOID PUTTING PRESSURE ON THE FRAME DURING DRILLING

Avoid putting pressure on the frame during drilling as this could misalign the drill bit and jeopardise the frame's correct alignment.

It is **essential to use both drill bits from the instrumentation set** to make the holes where the threaded pins will be inserted. Leave drill bit No. 1 in place to stiffen the construct proximally and drill the second hole using drill bit No. 2, making sure to cross both cortices each time. Leave drill bit No. 2 in place while assembling the first threaded pin.
