R-2019-001

URGENT – Field Safety Notice

TOMTEC-ARENA Patient Data Software Issue

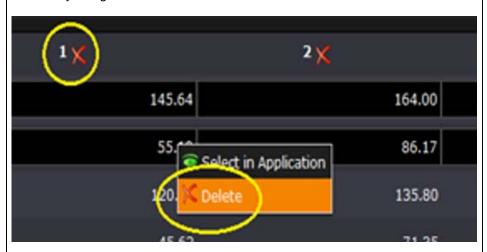
If a CAP is initiated and the clip/image is rejected with a message being displayed (see messages described under problem description), take the following actions:

- 1. Close the message dialog from the CAP and move back to IMAGE-COM
- 2. Press the Worksheet Button (
- 3. Navigate through the measurements menu and check all packages (4D LVA, 4D MVA, 4D RVF, 2D CPA, 4D CV) in all groups in the exam types Adult Echo and Pediatric echo.

- Exam Type (e.g. Adult Echo, Pediatric Echo, ...)
 - o Group (eg: Left Ventricle, Mitral Valve, Right Ventricle)
 - Package (e.g.: 4D LVA, 4D MVA, 4D RVF, 2D CPA, 4D CV)
 - SubPackage (optional)
 - Measurement
- 4. Once found, delete all measurements on the above described packages by using the available delete functions.

- All packages described above in the worksheet shall be completely empty.
- 6. Once finished, close the Worksheet.
