Urgent Field Safety Notice O-arm™ O2 Imaging System

January 2020

Medtronic reference: FA895 Phase II

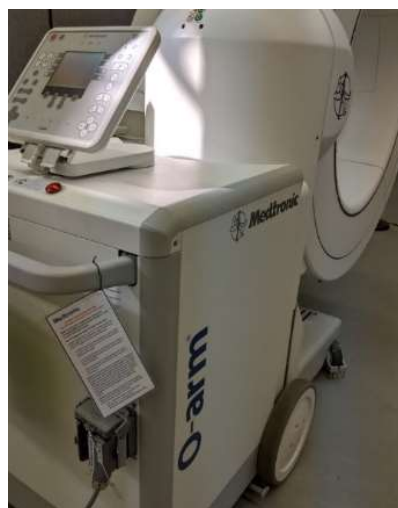
- 1) If you have not already done so, please attach the enclosed Visual Mitigation Card to the IAS of your O-arm™ O2 Imaging System, as illustrated below.

- 2) Please ensure that you have reviewed the information included in this notification with all users of the affected O-arm™ O2 Imaging System, including all physician users, and that the Visual Mitigation Card (VMC) has been attached to the affected system.
- 3) Work with your Medtronic representative to schedule the drive replacement and subsequent removal of the Visual Mitigation Card.
