URGENT: FIELD SAFETY NOTICE – VT-RAP-19-02-001 (Rev02)

EnCor® Breast Biopsy Probe
Impacted Product Codes/Lot Numbers - Refer to Table 1, Page 3
Type of Field Action: Advisory
UPDATED INFORMATION

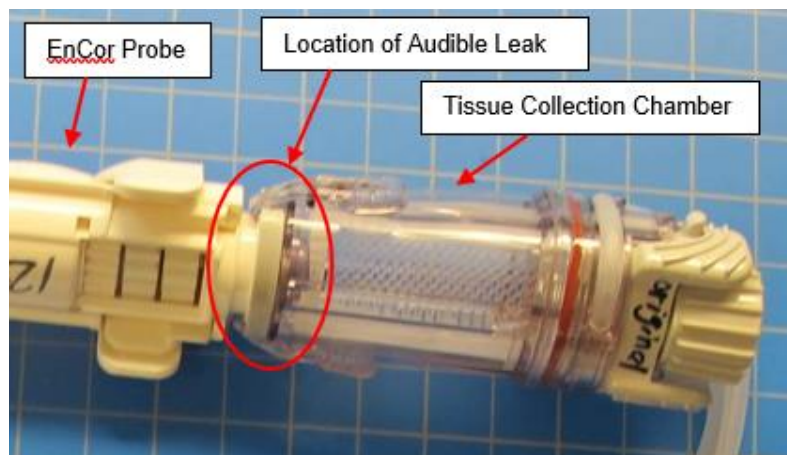
Figure 1: EnCor® Breast Biopsy Probe

The EnCor® Breast Biopsy Probe is used to acquire tissue for diagnostic sampling of breast abnormalities. Based on customer feedback, BD has identified that the product codes/ lot numbers listed in Table 1 on Page 3, may be at risk of experiencing a leak at the location referenced in the figure above, which could result in:

1. The sample chamber filling with blood with the potential to leak onto the driver and/or driver gears during the procedure and/or,
2. Minimal suction which has the potential to result in a minimal or no tissue sample obtained.

1. After calibrating the ENCOR® Breast Biopsy Probe, press and hold the VAC button on the ENCOR® Breast Biopsy Driver or the VAC button on the foot pedal. Inspect the probe and listen for any abnormal hissing sounds at the connection between the ENCOR® Breast Biopsy Probe and the Tissue Collection Chamber.

2. If any abnormal hissing sounds are heard, gently rotate the Tissue Collection Chamber a quarter turn in either direction until the hissing sound abates.

3. If the hissing sound remains, remove the Tissue Collection Chamber by depressing the wings on the chamber body and pull back on the Tissue Collection Chamber. Then reconnect the Tissue Collection Chamber by gently pushing it back on the ENCOR® Breast Biopsy Probe until the wings click back onto the probe body.

4. If the hissing sound is still present, replace the device and repeat the steps above. If the issue persists, please contact your local BD representative.
