# **Urgent Field Safety Notice**

ASW20-02.A.OUS January 2020

Atellica<sup>®</sup> IM 1300 Analyzer Atellica<sup>®</sup> IM 1600 Analyzer

# **Humidity Packs Incorrectly Identified as Expired (Lot 0010)**

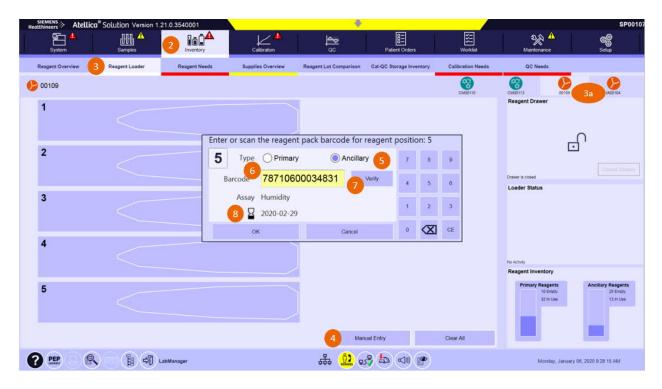
Note: Steps 2 through 8 correspond to the screen shot on page 3 below.

- 3. Select the Reagent Loader tab.
  - a. Select the **IM module** where the packs are to be loaded.
- 4. Select Manual Entry.
- 5. Select pack type as **Ancillary**.
- 6. Enter the following barcode number.
  - a. 78710600PPPPPP
  - b. PPPPPP is a unique six-digit pack number. Use the unique identifier on the Humidity Pack being manually entered.
  - c. The unique identifier on the Humidity Pack label is depicted below. In this example the unique identifier if 034831. (side view)

7. Select Verify.

- 8. Confirm Assay equals Humidity and the date next to the hourglass symbol is 2020-02-29.
- 9. Select OK.
- 10. Load the Humidity Pack in position 5 of the reagent tray.
- 11. Repeat this procedure for all required Humidity Packs. Each analyzer will require, 7 to 10 packs based on analyzer environmental requirements. When the full set of required Humidity Packs are loaded, the analyzer will resume normal operation.
