15<sup>th</sup> January 2019

**URGENT: FIELD SAFETY NOTICE – MMS-19-1572**

T34™ and T34L™ (T60™) Ambulatory Syringe Pumps

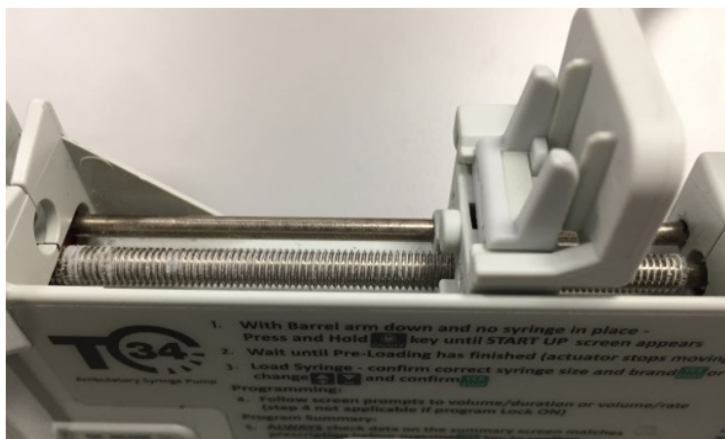
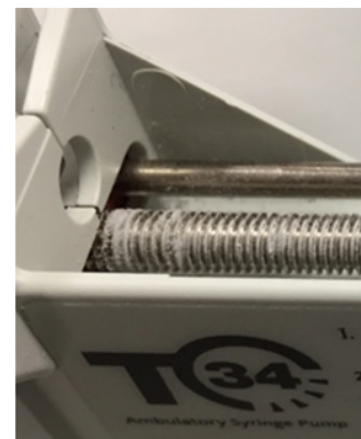
**Figure 1: Lead Screw & white plastic debris**

Through Post Market Surveillance feedback, BD/CME has identified that the syringe pump motor block mechanism may be affected overtime by “wear / tear”. This scenario causes **under infusion situations without the pump alarm being generated**.

The issue can be observed when the actuator does not move when the lead screw is rotating, resulting in potentially no pressure on syringe plunger to deliver the syringe contents. The cause of this issue is the actuator nut being worn enough to stop or lose traction on the lead screw due to irregular coating of the actuator. The “wear / tear” effect can be visually observed as the lead screw is progressively wearing the plastic actuator nut overtime, leaving white plastic debris along the lead screw (see Figure 1 below).

BD/CME has revised the Directions for Use (DFU) to include specific instructions for Users to check for plastic white debris on the lead screw during pump set up (Appendix 1). Also, BD/CME has updated the Technical Service Manual (TSM) instructions outlining changes to the maintenance and repair processes to check for plastic white debris on the lead screw and to preventively change the leadscrew and/or motor block assembly where necessary. The pump has to be checked **prior each use for plastic white debris**. Users responsible for pump set-up need to doublecheck that the infusion rate and amount was as prescribed, due to the fact that the pumps will **not alarm** the user in case of underinfusion.

Inspect the lead screw prior to use (See 3.2 Pump Description, item 4). If there is white plastic debris on the lead screw, this is an indication of wear on the syringe mechanism. Therefore, discontinue use and send the pump for service.
