FSN 2020-IGTPUN-004 - FCO71800085

URGENT – Field Safety Notice

Zenition 50 and Zenition 70

Loss of strain relief in the interconnecting cable between the Mobile Viewing Station and the C-arm Stand
(Stand MVS Trolley Cable)

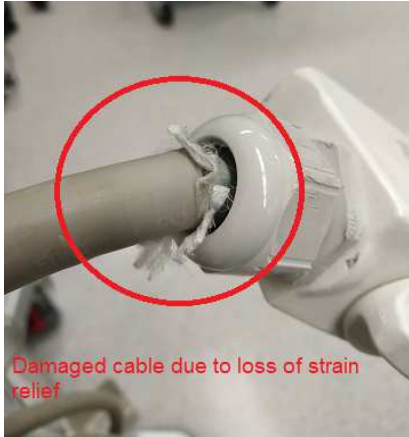
<p>Damaged cable due to loss of strain relief</p>
HAZARD INVOLVED	<p>In the event of strain relief loss, the following are potential hazards:</p> <ul style="list-style-type: none">• Electric shock if a live part is touched (230V)• Delay in treatment due to interruption of procedure or system not being available when needed.
HOW TO IDENTIFY AFFECTED PRODUCTS	<p>Affected systems contain the cable 459800943703 (Stand MVS Trolley Cable).</p> <p>Users can identify if their Zenition 50 (Product Code: 718096) and Zenition 70 (Product Code: 718133) contain this cable by checking the plastic nut of the cable.</p>

<p>In case the strain relief is lost and / or damage to cable/ connector is identified; stop using the system and contact your Philips local representative so that the cable can be replaced.</p>	Check	Description	Frequency	Cabling	Inspect all cables for kinks and/or cracks	Daily	Connectors	Check correct connection and damage	Daily
Check	Description	Frequency								
Cabling	Inspect all cables for kinks and/or cracks	Daily								
Connectors	Check correct connection and damage	Daily

<ul style="list-style-type: none">○ Please ensure that all staff working with the system are informed of the content of this safety notice and place a copy of it with the Instructions for Use.
ACTIONS PLANNED BY PHILIPS	Philips will be replacing the Stand MVS Trolley Cable (459800943703) in all affected systems by a new Stand MVS Trolley Cable that has an improved strain relief design. This action will start in May 2020. You will be contacted by our local Philips representative to schedule an appointment to replace the cable.
FURTHER INFORMATION AND SUPPORT	If you need any further information or support concerning this issue, please contact your local Philips representative: 0800 80 3000
