URGENT - Field Safety Notice ***TraumaDiagnost***

Check of integrity for Trauma Arm

FSN MA FCO-72000015 April 2020

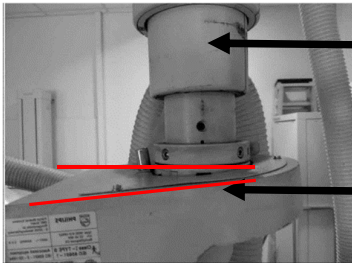
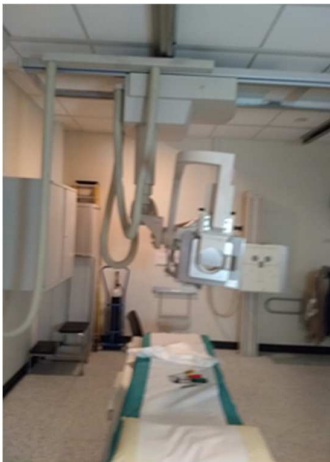
HOW TO IDENTIFY AFFECTED PRODUCTS	<p>An operator noticed an unusual angle of the trauma arm with respect to the telescopic column of the ceiling suspension.</p> <div style="display: flex; align-items: center;">

<div style="margin-left: 10px;"> <p>Telescopic column of ceiling suspension</p> <p>Supporting block</p> </div> </div>

ACTION TO BE TAKEN BY CUSTOMER / USER	<p>The IfU (Instruction for Use) require the operator to not use the system and call for service, if a mechanical defect or malfunction is suspected. As soon as a deformation is determined, the system may no longer be used and call the service engineer. Should you feel uncertain regarding these instructions, please contact Philips.</p>
ACTIONS PLANNED BY PHILIPS	<p>The affected systems will be get an onsite check of the status of the Trauma arm for deformations as shown on the pictures.</p>
FURTHER INFORMATION AND SUPPORT	<p>If you would like any further information or support concerning this issue, please contact your local Philips representative:</p> <p>0800 80 3000</p>
