# **IMPORTANT FIELD SAFETY NOTIFICATION**

**Subject:** Potential image to contour mismatch during Motion Monitoring

**Product:** Elekta Unity

**Notification Released:** February 2021

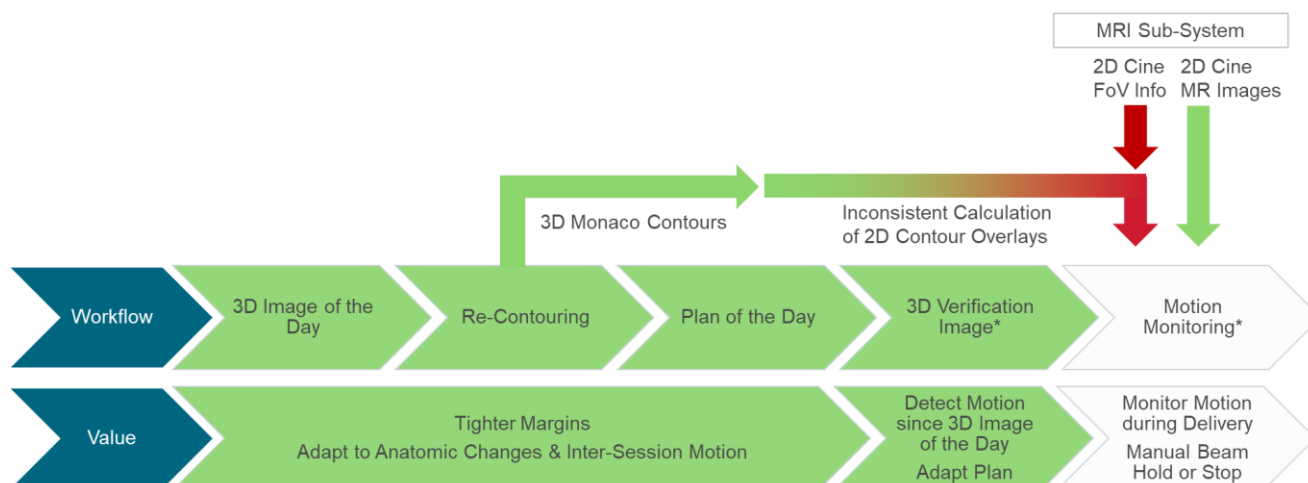
Schematic Representation of the Elekta Unity Clinical Workflow showing that both the Field-of-View information used in the calculation of the 2D Contour Overlays as well as the calculation itself are impacted (red). The steps preceding visual Motion Monitoring, as well as the 2D MR Cine images are not impacted (green).
