URGENT FIELD SAFETY NOTICE

Incipio Devices – OFFSET CUP IMPACTOR
Product Deficiency

RE: **URGENT SAFETY INFORMATION**

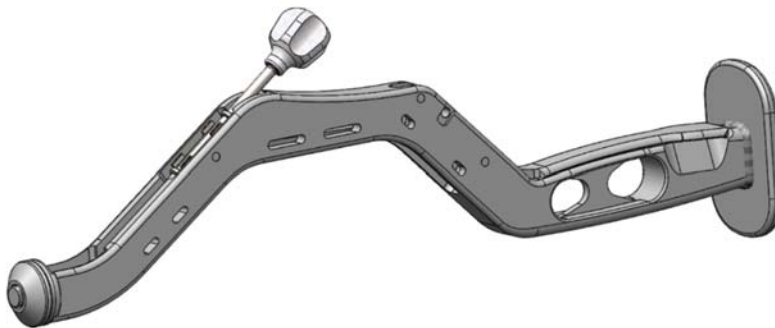
Offset Cup Impactor (as sold)

Positioning Handle Assembly

Incipio Devices has become aware of an issue with specific lots of **OFFSET CUP IMPACTORS** following an incident in which a pin from the device's positioning handle assembly fell out during surgery and remained lodged in the patient's acetabulum behind the implanted cup. Subsequent investigation revealed that the weld joints of the cardan did not meet the weld depth specification required.

The weld depth of the pins of the cardan joint do not meet specification on certain lots of product. The deficiency of the weld depth may cause premature failure of the positioning handle assembly. Failure of the welds may result in the retaining pins falling into the surgical site, causing an extension of surgery time. If the loss of the pin is not detected prior to wound closure, possible consequences are patient tissue irritation and the possible need for surgical intervention to remove it.

Please note: Only the Positioning Handle Assembly component must be returned. The impactor body may be retained and used with replacement components.
