## Urgent Field Safety Notice

### Update to address Numerical Format Issue in the CT900 Clinician Programmer via Model A810 SynchroMed™ II Software Application for Version 1.1.342

Medtronic Reference: FA920

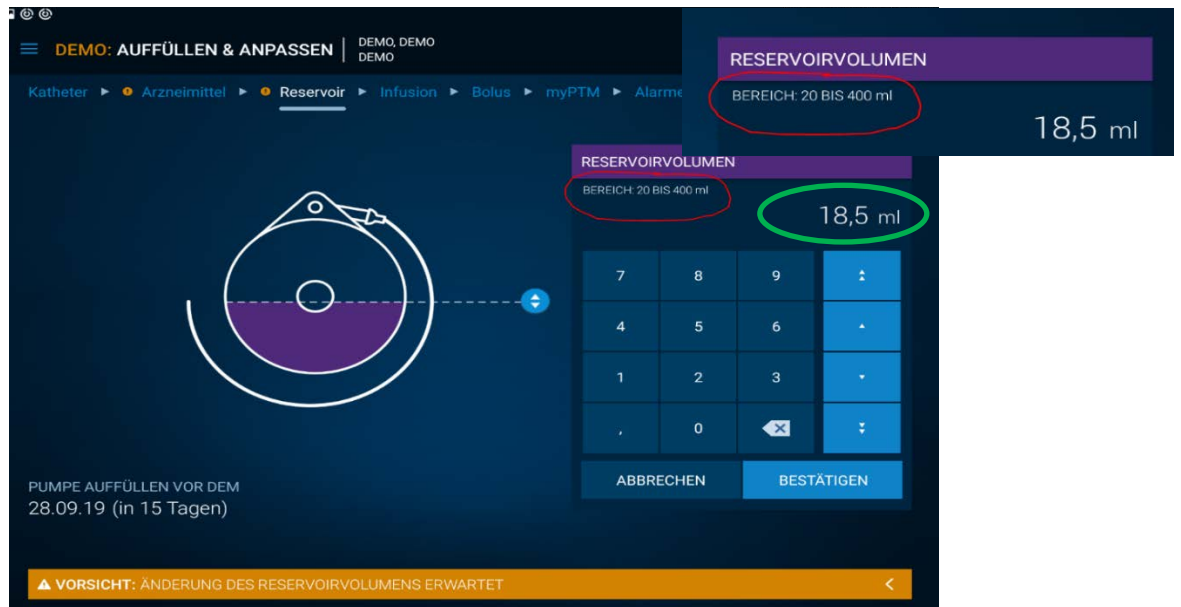
Figure 1: Incorrect values displayed for the allowed range of the reservoir volume (200 – 400 ml): Data entered by HCP is correct (18.5 ml)

Please download the latest update to the A810 SynchroMed II Software Application, version 1.1.342, to the CT900 Clinician Programmer following the enclosed instructions.

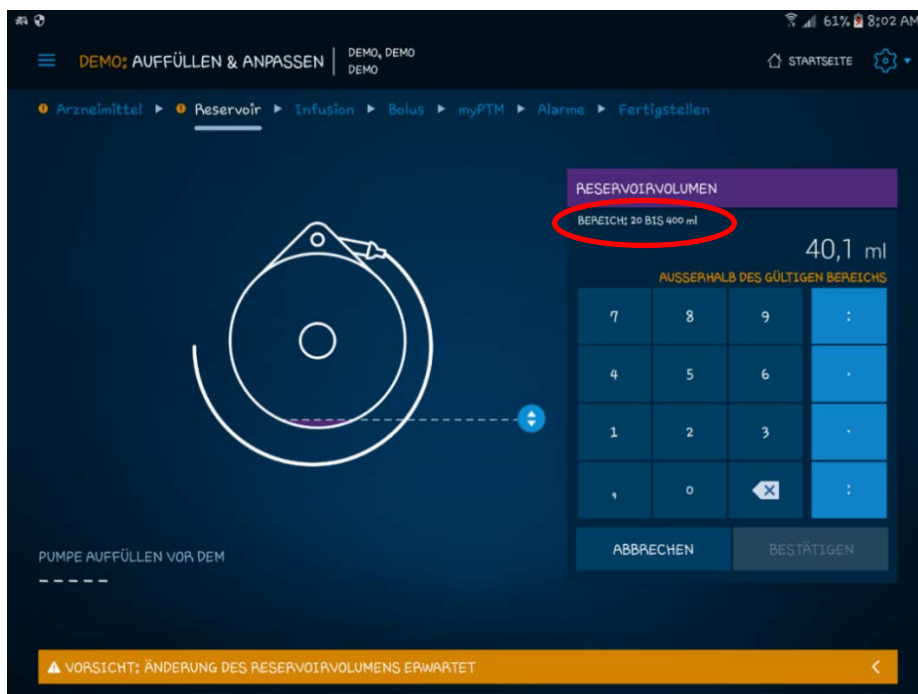
Figure 2: Value 40,1 cannot be entered even though the displayed range text indicates it can
