15.07.2020

## URGENT – FIELD SAFETY NOTICE

### SICAT IMPLANT V2.0

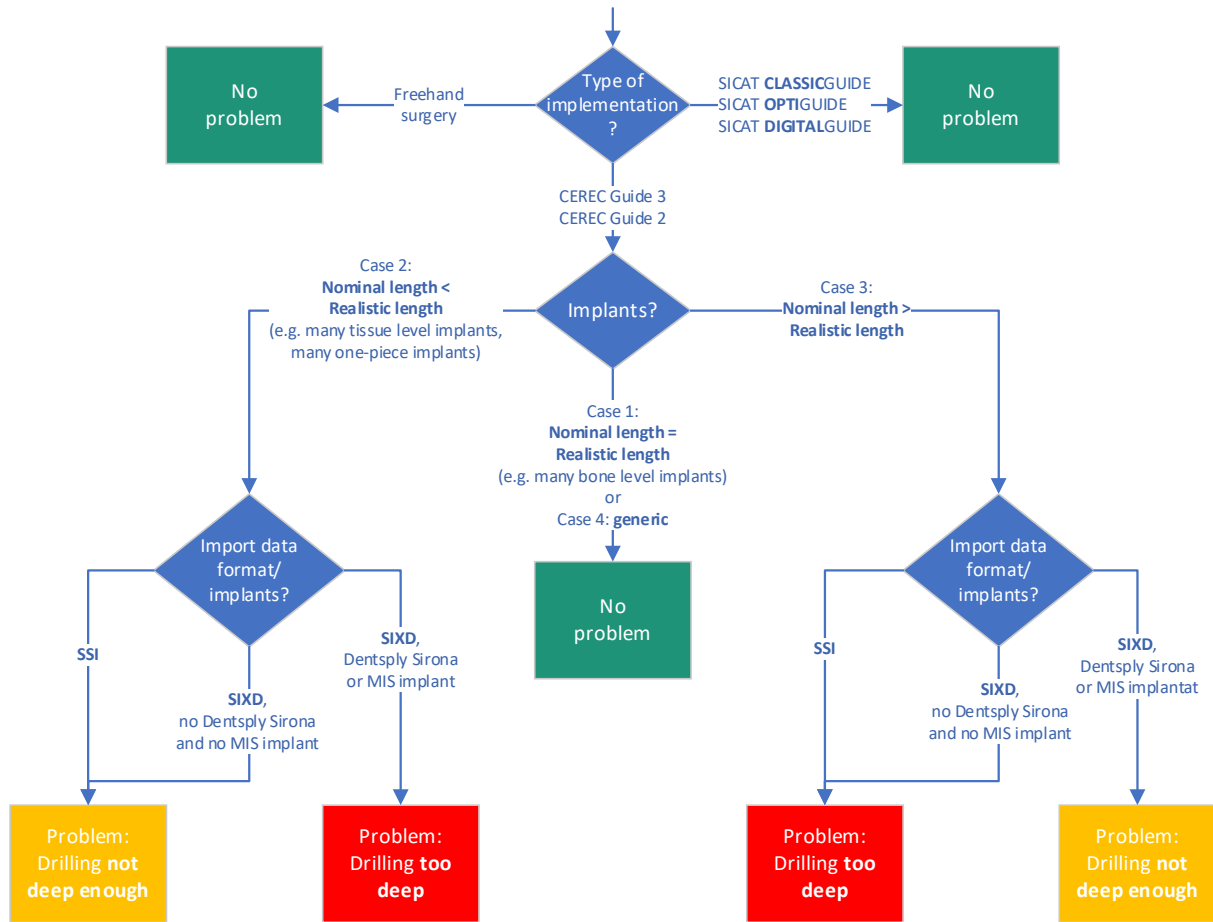
In certain cases (see figure 1), the error leads to the planned implant-sleeve combination being exported shifted by a positive or negative offset along the implant axis. The offset is the difference between the **nominal implant length**<sup>1</sup> and the **realistic implant length**<sup>2</sup>. The sign of the offset also depends on the format of the import data (SSI, SIXD) (see figure 1). The exported CMG.DXD file is incorrect in these cases.

Ultimately, the error for the affected implants means that when a CEREC Guide is used, the **drilling is predominantly not deep enough** or the **drilling is too deep**. In the latter case, anatomical structures in the jaw such as nerves, maxillary sinuses, roots or bone can be damaged.

Figure 1: In which cases does the error occur and with what consequences?

The export for a CEREC Guide ("CMG.DXD export") in SICAT IMPLANT V2.0 may only be used for the unaffected implants (Case 1 from Table 1), otherwise the patient may be harmed.

It is expected that a patch fixing the error will be available for download for all customers in July 2020 in the form of a SICAT SUITE V2.0.1 with SICAT IMPLANT V2.0.1. As soon as this patch is available, all affected customers will be informed. Customers who want to use SICAT IMPLANT must download and install SICAT SUITE V2.0.1 with SICAT IMPLANT V2.0.1 and activate SICAT IMPLANT V2.0.1.
