To all user of Siemens Cios Systems Spin & Alpha

Customer Safety Information (CSI) for Field Safety Corrective Action: AX014/20/S

Subject: Field Safety Notice for: Exchange of a printed circuit board (“main control D80” with revision less than 04) which is included in certain Cios Spin & Cios Alpha systems.

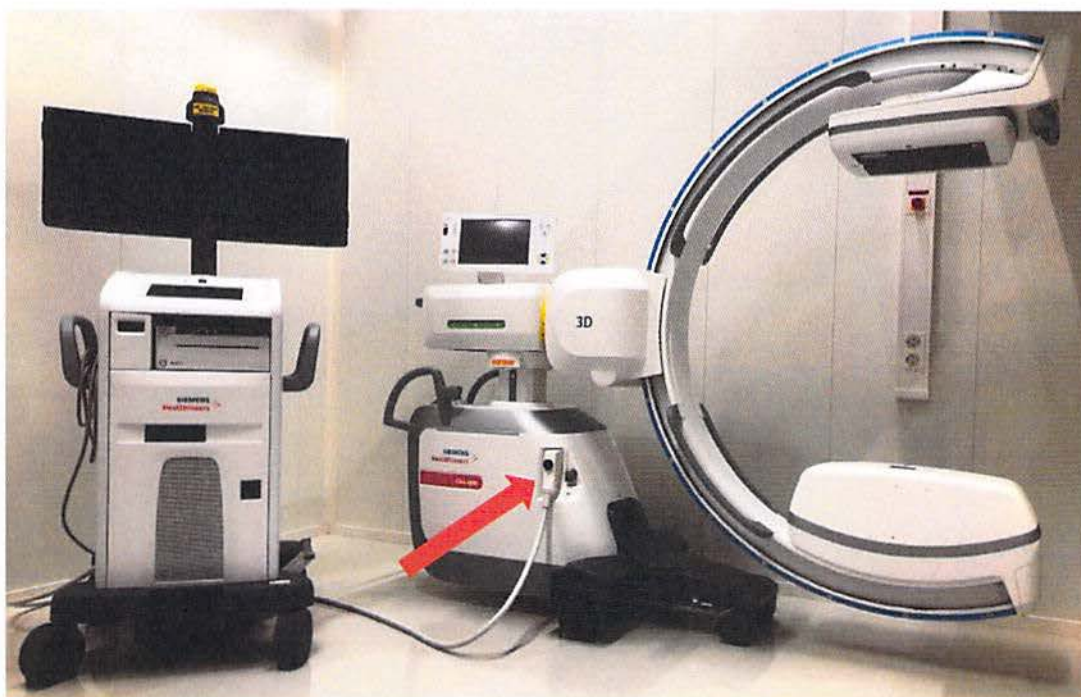
Our Cios systems offer a “hot plugging” feature between trolley and main unit (c-arm). The “hot plugging” feature enables the clinical user to plug/unplug the X10 connector of the main cable (please refer to figure 1 below) at any time during clinical session, provided that the system is electrically connected and powered on. In very few cases the “hot plugging” feature could cause an electrical malfunction on the main control D80 of the generator which is part of the main unit (c-arm).

figure 1: example of X10 connector with main cable, connected to Cios Spin c-arm

The subject was identified during a demo session when application engineer wanted to perform the “hot plugging” feature of a Cios Alpha VA30 system. The root cause is a design flaw in the component main control D80 with revision less than 04.

We advise urgently to cease the use of the above-described “hot plugging” feature until the pending hardware update AX014/20/S has been completed.

A service engineer will replace the main control D80 of your affected system by a revised main control.
