**syngo.via RT Image Suite**  
with *syngo.via* VB30 and *syngo.via* VB40 software  
with licence for patient marking with external lasers  
(technical name of the license:  
"CT RT IMAGE SUITE PAT MARK")

**Customer Safety Advisory Notice SY051/20/S**

**SOMATOM go. CT Scanners with  
syngo.RT Image Suite**  
with *syngo.CT* VA20A, *syngo.CT* VA30A  
with licence for patient marking with external lasers  
(technical name of the license:  
"CT RT IMAGE SUITE PAT MARK")

**Subject: Incorrect calibration offset between CT central image plane and external lasers after update/upgrade potentially resulting in an unprecise cancer treatment**

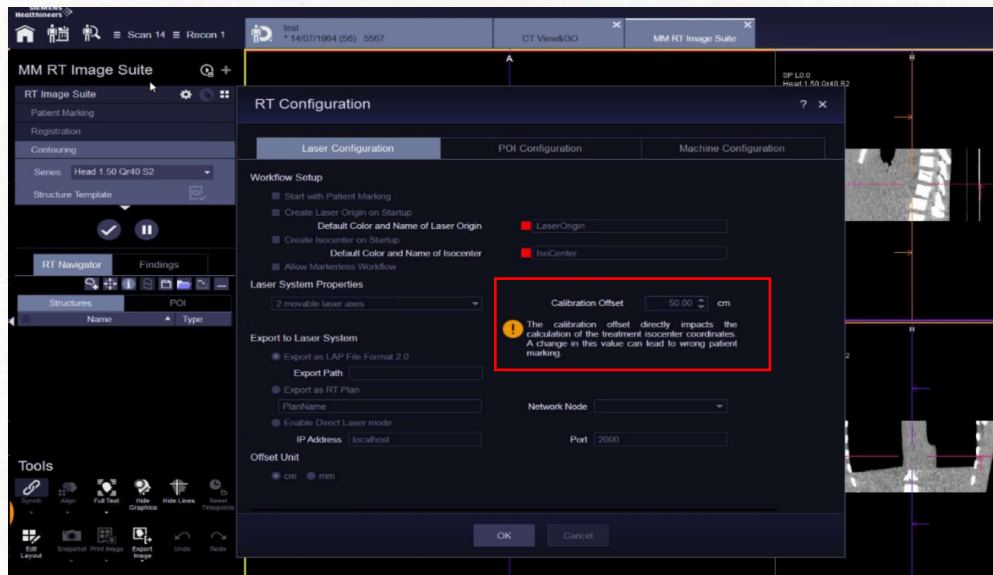
The calibration offset between the central CT image plane and the external RT lasers has been set automatically to the factory default of 50.00 cm, if your *syngo.via* RT Image Suite has been updated or upgraded to one of the following software versions:

Figure 2: MM RT Image Suite Configuration dialog with the marked parameter

Please update the calibration offset in the MM RT Image Suite Configuration dialog accordingly as shown below in Figure 2. Details of this procedure are documented in Chapter 13.2 (Laser configuration) of your user manual.
