## URGENT FIELD SAFETY NOTICE

### Neuroinspire Instructions for Use - Depth Offset Image Error

Renishaw Mayfield FSN Reference: VR-20-3

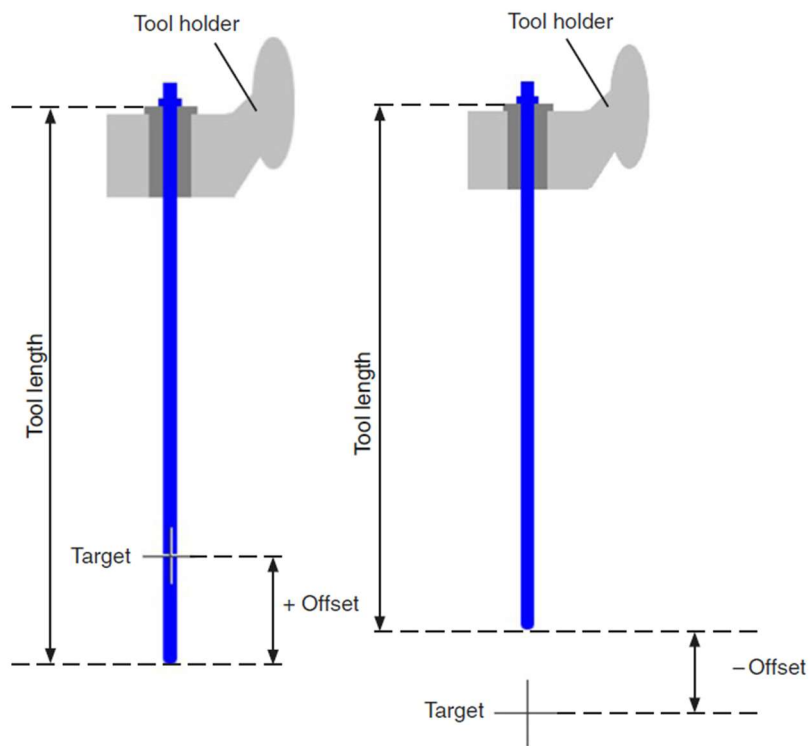
*Figure 2 - Correct image:*

<p><b>AFFECTED PRODUCTS</b></p>	<p>Two Instructions for Use are affected:</p> <ul style="list-style-type: none"> <li>• Neuroinspire Neuromate Module Instructions for Use (H-5630-3016 versions A2-A6)</li> <li>• Plan Delivery USA Instructions for Use (H-5630-3050-A1)</li> </ul>
<p><b>PROBLEM DESCRIPTION</b></p>	<p>In Section <b>3.4 Move to Trajectory</b> of the Neuroinspire Neuromate Module Instructions for Use (H-5630-3016-A6) and the Neuroinspire Plan Delivery Instructions for Use (H-5630-3050 A1), the bottom right image (figure 1) showing a negative offset is incorrect. The horizontal dotted lines in the image have incorrectly shifted downwards in the image. The image (below, right) suggests that the tool length is taken from the top of the tool holder instead of the top of the guide bush.</p> <p><i>Figure 1 - Incorrect image:</i></p> <p><b>a.</b> The dotted lines are shifted on the bottom of the drawing; the tip of the tool does not touch the dotted line.</p> <p><b>b.</b> The datum point should be level with the guide bushing.</p> <p><b>c.</b> The dotted line should be level with the target</p>

<p>Please note that it is clearly written and repeated in the instructions that “the tool length is <u>always</u> measured from the back face of the guide bushing” / “the tool length is the distance from the back face of the guide bushing to the tip of the instrument” .</p> <p>All other images and text in the IFU confirm the correct instructions. Training provided to the clinician also informs the user that the tool length is measured from the back of the bushing.</p>
<p><b>HAZARD INVOLVED</b></p>	<p>The difference in position of the back of the tool holder and the back of the bushing from the target is 2mm.</p> <p>This is in conflict with the other information provided and could cause confusion to the user.</p> <p><b>First scenario:</b> User experiences confusion and surgeon then carries out a confirmatory check or request further assistance from Renishaw to determine if tool/implantable can be delivered to the correct depth. The confirmatory check by the surgeon would lead to potential increase of general anaesthetic exposure to the patient.</p> <p><b>Second scenario:</b> By using this incorrect datum position, the user could unintentionally create a 2mm positive offset from the intended position of the tool/implantable. Upon delivery, the tool/implantable would be positioned 2 mm beyond the distal end of the planned position. The resultant harm to the patient would range from minor damage to brain structures, to serious harm.</p> <p>As surgical planning should always consider the overall accuracy of the system and the nearby structures, users are unlikely to create plans with critical structures being <math>\leq 2</math> mm from the of the end of the tool/implantable. Also, the incorrect image highlights the negative offset where the tip of the tool is planned at a point short of the target. The likelihood that a clinician would plan a surgery with critical structures within this 2mm region is considered very low.</p> <p>Due to all additional information within the IFU being correct and the user-training provided, the likelihood of the user being aware of the need to account for this 2 mm difference is considered low. The user is most likely to question the conflicting information and carry out their own checks or raise it with Renishaw service staff rather than acting against the training received.</p>

<p><b>ACTION TO BE TAKEN BY CUSTOMER / USER</b></p>	<p>Please stop using the referenced Instructions for Use and take note of amendment/reinforcement of the correct image relating to negative offset requirements.</p> <p>Users are informed that the following image (figure 2) is now corrected and will soon be provided in an updated Instructions for Use. Users are informed that all consideration of tool length should be measured from <b>the back face of the bushing</b> in all cases and to contact Renishaw should they have any queries</p>

Renishaw Mayfield shall send the correct version of the affected Instructions for Use to affected sites free of charge. A software update shall be rolled out to correct the electronic IFU.
