Urgent Device Correction

Elevated Temperature of Receive Coil Components When Using Select Ciné Treatment Imaging Sequences

UDC 2020-001

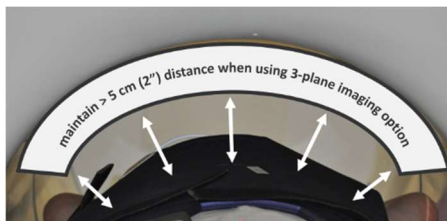
Figure 3: Distance between receive coil and inner surface of bore wall is more than 5 cm

Do: Maintain a distance of at least 5 cm (~2") between the receive coil and the inner surface of the bore wall when using 3 Plane ciné treatment imaging (Figure 3 & 4).

Do Not: Select 3 Plane ciné treatment imaging if a distance of at least 5 cm (~2") cannot be maintained between the receive coil and the inner surface of the bore wall during treatment.
