**Field Safety Notice (FSN)  
Pulla StretchLift  
Improving safety through retrofitting**

unintentional actuation  
pulla StretchLift  
Article-Nr. 8266001  
Serial numbers 0001 – 3738  
Attaching a deflector plate  
Article-Nr. 8101617

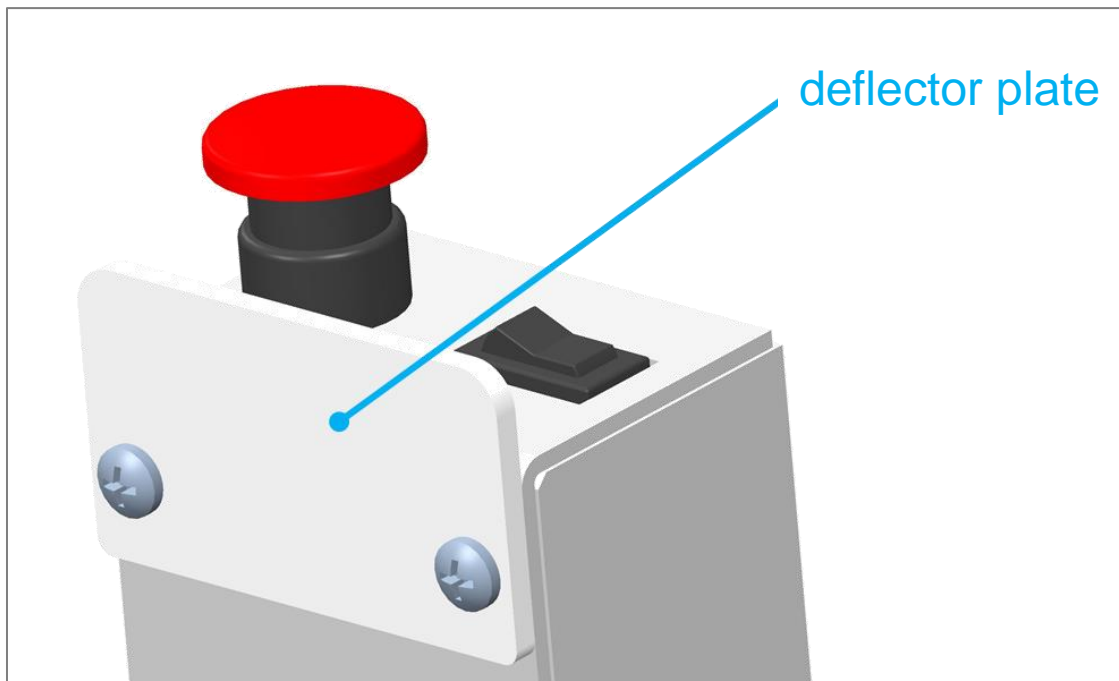
an incident in which improper use was responsible for the fact that the control button was unintentionally pressed and pulla was unintentionally started, prompts us to carry out this (FSCA).

**Corrective actions**  
Attaching a deflector plate.  
This corrective action has to be taken.
