URGENT - FIELD SAFETY NOTICE
Telemis-Medical Software
Reference FSN 25512

Date : 16th December 2020

Telemis recently discovered an issue with the mammo / tomo functionality that can potentially cause the tomo track bar to display incorrectly.

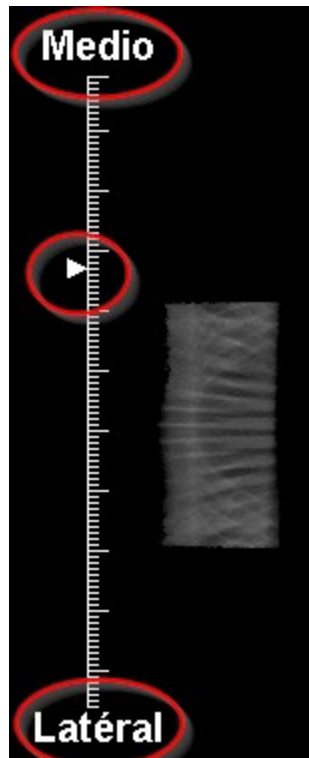
Problem 1: laterality issue

The position of the image in relation to the laterality indicators in the navigation track bar can be reversed. For example, the cursor may be located on the “medio” side while the image is actually on the “lateral” side.

This issue was detected on ML, MLO views.

Correction will be available as part of a software patch expected in December 2020.

In the meantime, users should be vigilant and take extra care when viewing such tomo images. The display order is usually Left CC / Right CC / Left MLO / Left Tomosynthesis / Right MLO / Right TMS, but there are different working protocols. In all cases, it is imperative to have the 2 base incidences with unambiguous marking

As soon as the new release of the software is available, your *Telemis-Medical* installation will be updated, free of charge, and you will be informed of the correction.

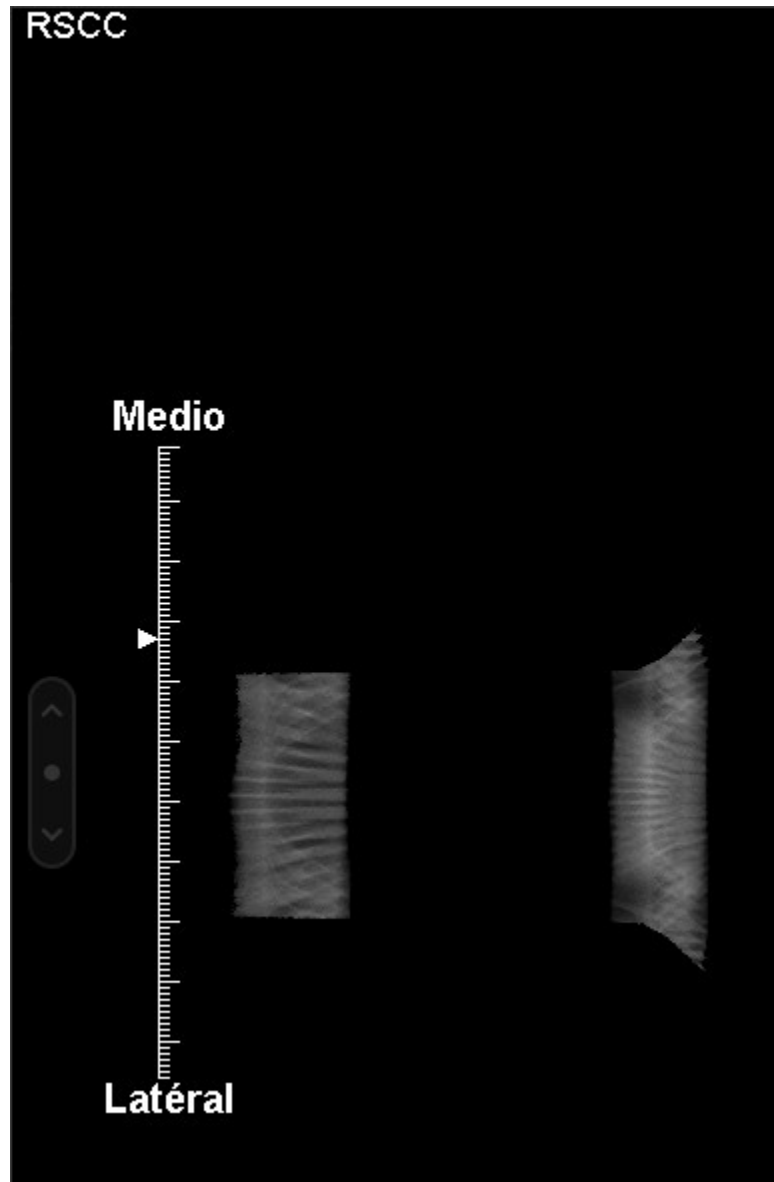
Problem 2: ML navigation bar for CC

If a CC tomo series contains the attribute "View Modifier Code Sequence" (0054,0222), it can be detected as having an ML view. See the example below (the navigation bar displays Medio-Lateral instead of Cranio-Caudal):

Note: in this case, the indexName in the database is "RSCC" ("S" is the Viewer Modifier Code). It needs to be RCC for the track bar to be correct.
