URGENT: FIELD SAFETY NOTICE – MMS-20-3893

BD BodyGuard™ Duo Infusion Pump

Product Codes: 999-903EN; 999-903ES; 999-903IT

BD BodyGuard™ Duo Infusion Pump – Software Upgrade

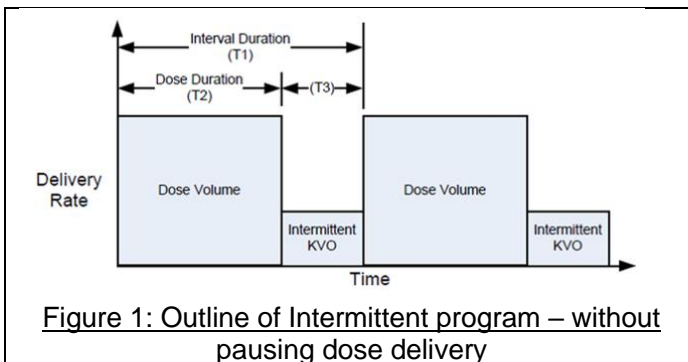
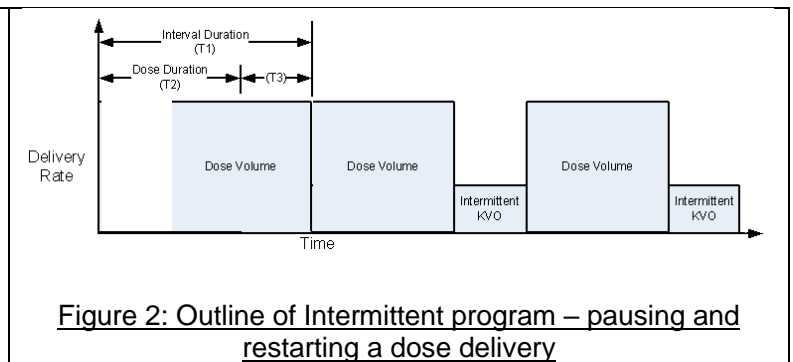
If the pump is turned off during intermittent program, the internal clock continues to monitor the timing of the infusion. Refer to Figure 1 below for an outline of the intermittent program. Basically, the pump will try to keep the interval time (T1) consistent across the infusion program. A software upgrade will be rolled out by BD to ensure that any pause of the dose duration (T2) is added to the interval duration (T1). Until then BD advises Users of the following, if using the Intermittent Program:

- If the pump is stopped during a dose (T2), the operator will be able to resume the remaining time. The pump will keep the interval time (T1) fixed. In the case of a short interval time, the KVO time (T3) will be reduced by the time of the interruption (Figure 2).
- If the pump is stopped during a dose (T2) and restarted after the next scheduled dose time has passed, the pump will start the next dose immediately from the beginning followed by a complete interval as set by the operator. It will not administer the remaining previous dose.
- If the pump is stopped during the Intermittent KVO (T3), the user can restart the pump any time before the next scheduled dose without impacting the infusion program. If the pump is restarted after the next scheduled dose, the pump will start with the next dose immediately followed by a complete interval (T3).

- If the User is not aware of the points above relating to the Intermittent program, there is the potential to administer two consecutive doses without a pause between the two doses. This could lead to an over-infusion and result in patient harm depending on the drug being administered.
- BD has not received any reported events associated with this issue.

- BD will roll out a software upgrade and revised DFU for the BodyGuard™ Duo Infusion pump
 - This software will update the Intermittent program to ensure that if the Dose Duration (T2) is paused the overall interval duration (T1) will be increased by the amount of time of this pause.

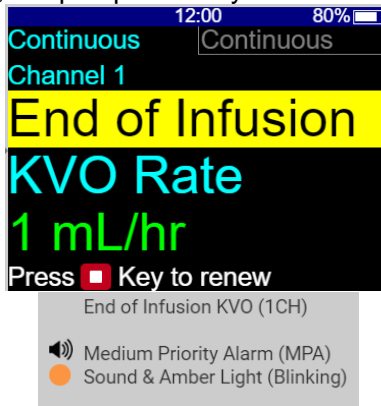
In the case of End of Infusion with KVO, the pump currently alarms as a medium priority alarm:

- Clinicians may not be able to differentiate between the NEOI (low priority) and EOI (medium priority) alarms and may react incorrectly.
- A potential drop of the flow rate may cause an under-infusion resulting in patient harm depending on the drug being administered.
- BD has not received any reported events associated with this issue.

- BD will roll out a software upgrade and revised DFU for the BodyGuard™ Duo infusion pump
 - This software will update the alarm priority as high for the EOI (End of Infusion) with KVO (Keep Vein Open)

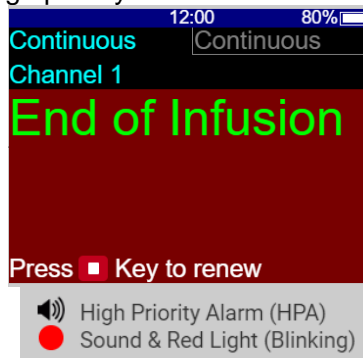
Once the KVO has been completed, a high priority End of Infusion alarm is activated:
