Urgent Field Safety Notice **MiniMed™ 780G insulin pump: MMT-1885, MMT-1886** **Pump Kit: MMT-1895, MMT-1896** **Pump Errors After Quick Bolus**

March 2021

Medtronic reference: FA963

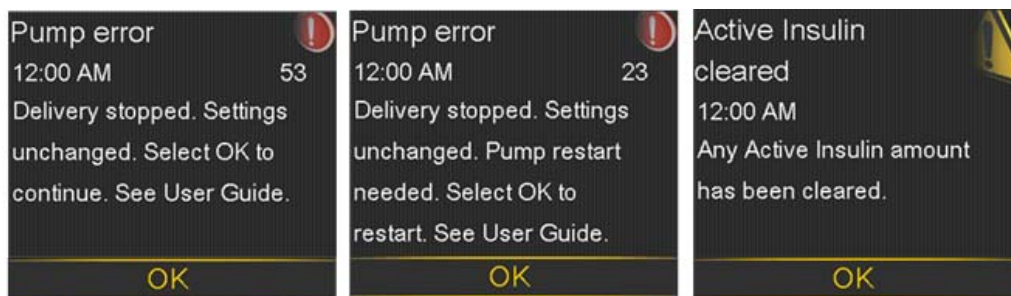
If all the above conditions are met, within 2 minutes of bolus delivery completion, the pump initiates Pump error 53, followed by Pump error 23 alarm. The following screens are presented in the pump screen:

Upon clearing the pump errors, the pump resets and indicates Active Insulin has been cleared. The pump then guides the user to resume operation in Manual Mode. The SmartGuard™ status screen indicates the warm-up period has started. After approximately 5 hours, the SmartGuard™ feature will be available.

Since Active Insulin will display 0.0 units in the pump after experiencing the pump errors above, if the user is not aware of the amount of active insulin and delivers an additional bolus, there is a risk of insulin over delivery, which may result in low blood sugar (hypoglycemia) or severe hypoglycemia. In rare cases, severe hypoglycemia, if left untreated, may lead to a life-threatening situation. As of January 21, 2021, Medtronic has received no reports of serious patient harm or serious injury related to this issue.

1. Although insulin was delivered before the error and you may have insulin on board, Active Insulin is reset to 0.0 units on the pump screen.
2. Before delivering additional boluses, check your graph or history to understand how much insulin was delivered before the error.
3. Consult your healthcare professional about your active insulin absorption and how to plan a bolus if active insulin has been reset to 0.0.

1. **Wait** at least 2 minutes between boluses if you need to deliver multiple boluses that exceed 17.1U in total.
2. **Consult** your healthcare professional about setting your maximum bolus limit to 17U or less.
Note: The default setting is 10U.
