URGENT – FIELD SAFETY NOTICE

Nimbus 4 & Nimbus Professional mattress – risk of over-inflation

Affected Product: Arjo Nimbus 4 & Nimbus Professional mattress

Field Safety Notice: FSN-SUZ-001-2021

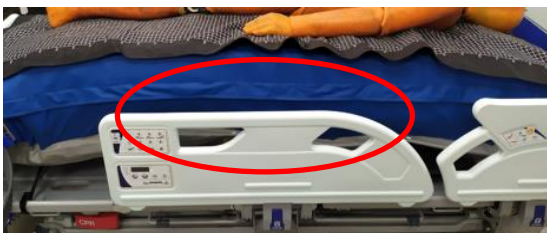
Our investigation has concluded that there is a remote possibility that a patient could fall from the mattress if the issue was to occur and was not detected by care givers. The issue is caused by inner mattress components that may fail after a certain period of time, however this is extremely rare and unfortunately cannot be detected until the product is disassembled.

Malfunctioning
mattress

1. Transfer the patient to another appropriate surface
2. Turn off and unplug the pump.
3. Perform grommet membrane deactivation as instructed in the video to allow the accumulated air to freely vent out. Use a screw driver with a diameter of 2 – 3 mm. Make sure that the membrane is punctured through.
