Welch Allyn, Inc. 4341 State Street Road Skaneateles Falls, NY 13153 USA	URGENT: Field Safety Notice	FA-2021-05-001-SKF-004
---	------------------------------------	------------------------

Braun® ThermoScan® Pro 6000 Ear Thermometer

Potential risk of probe tip overheating

FSCA-identifier: FA-2021-05-001-SKF-004

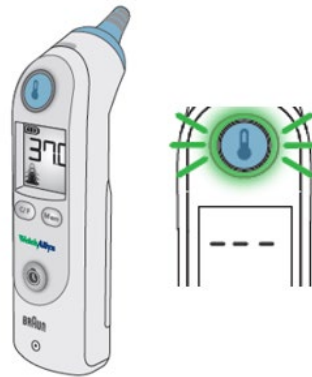
Our investigation has confirmed that the probe tip overheating is the result of fluid ingress. Fluid ingress causes the sensor to behave inconsistently, which does not allow the built-in safety mitigation (turn off the heating element) to work correctly. The majority of the devices which experience overheating of the probe tip show one of two behaviors at time of power up:

1. The ring around the measurement button will show a green blinking or flashing light instead of a ready state (solid green light).
2. The device requires multiple power-ups prior to going to ready state (solid green light).

1. Please share this communication with all potential users in your organization and instruct them to follow the provided Cleaning Guide for proper cleaning.
2. Do not use the device if the ring around the measurement button shows a green blinking or flashing light instead of a "ready state" (solid green light) and contact Hillrom Customer Service to report this issue.

3. Do not use the device if the device requires multiple power-ups prior to going to “ready state” (solid green light) and contact Hillrom Customer Service to report this issue.
4. If you experience an overheating probe tip, do not use the device and contact Hillrom Customer Service to report the issue.
5. Complete the attached response form and return to HillromSKF004OUS@hillrom.com within one month.
