## **URGENT Field Safety Notice**

Trilogy Evo and Trilogy Evo O2

August 2021

**Reference: Trilogy Evo and Trilogy Evo O2 (2017-07-A)**

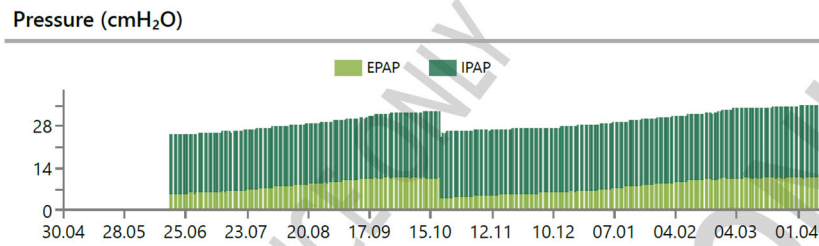
When a Trilogy Evo or Trilogy Evo O2 model is used continuously without any interruption of therapy over weeks to months, the baseline pressure (that is, the pressure initially set for the patient) may increase or decrease at a rate of up to approximately 2 cmH<sub>2</sub>O per month. This increase applies to the PEEP and the inspiratory pressure at the same rate. The maximum pressure deviation that could be seen is a 10 cmH<sub>2</sub>O shift from the baseline pressure. The pressure regulation alarms will not announce with this issue.

- i. The Respiratory clinician or Physician can detect the increase/decrease in pressure by observing the pressure Trend report in Care Orchestrator/Care Orchestrator Essence as shown below.

**If a pressure drift is detected, the decision to reset the device and return to its original, intended settings MUST be made in consultation with a clinician. Take steps to support the patient during a brief interruption in therapy, as needed.**

The following actions can be taken to reset the device back to the original settings:

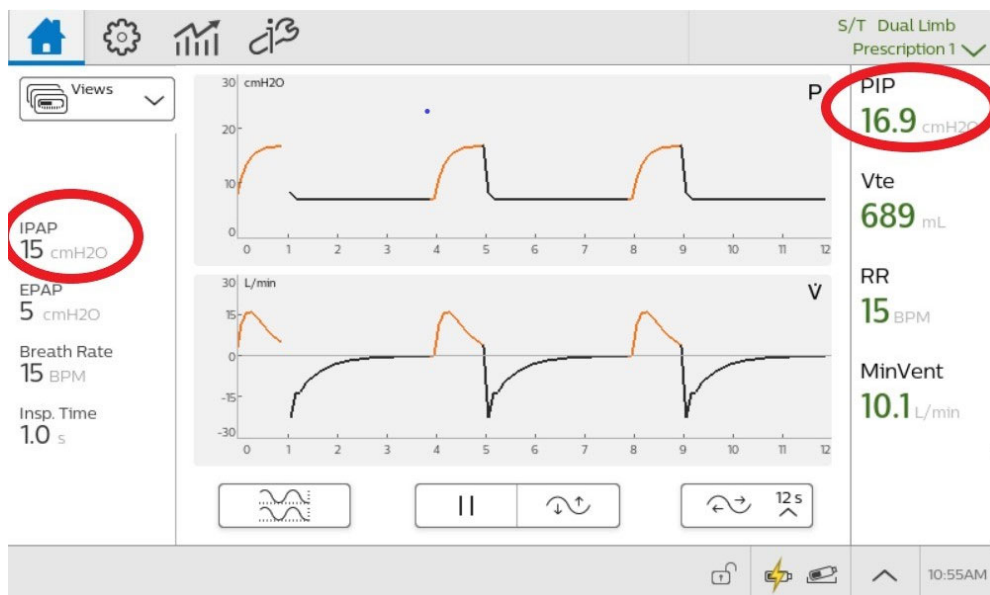
- ii. The caregiver can detect the increase in pressure by observing the measured parameters on the device's screen (measured PIP value or pressure waveform as shown below where the IPAP is set to 15 cmH<sub>2</sub>O but because of the pressure increase the actual delivered pressure is 16.9 cmH<sub>2</sub>O).
